## Deepwater Sidescan Sonar and Camera Surveys for Derelict Fishing Nets and Rockfish Habitat

THE NORTHWEST STRAITS FOUNDATION

NATURAL RESOURCES CONSULTANTS, INC.

January 24, 2011

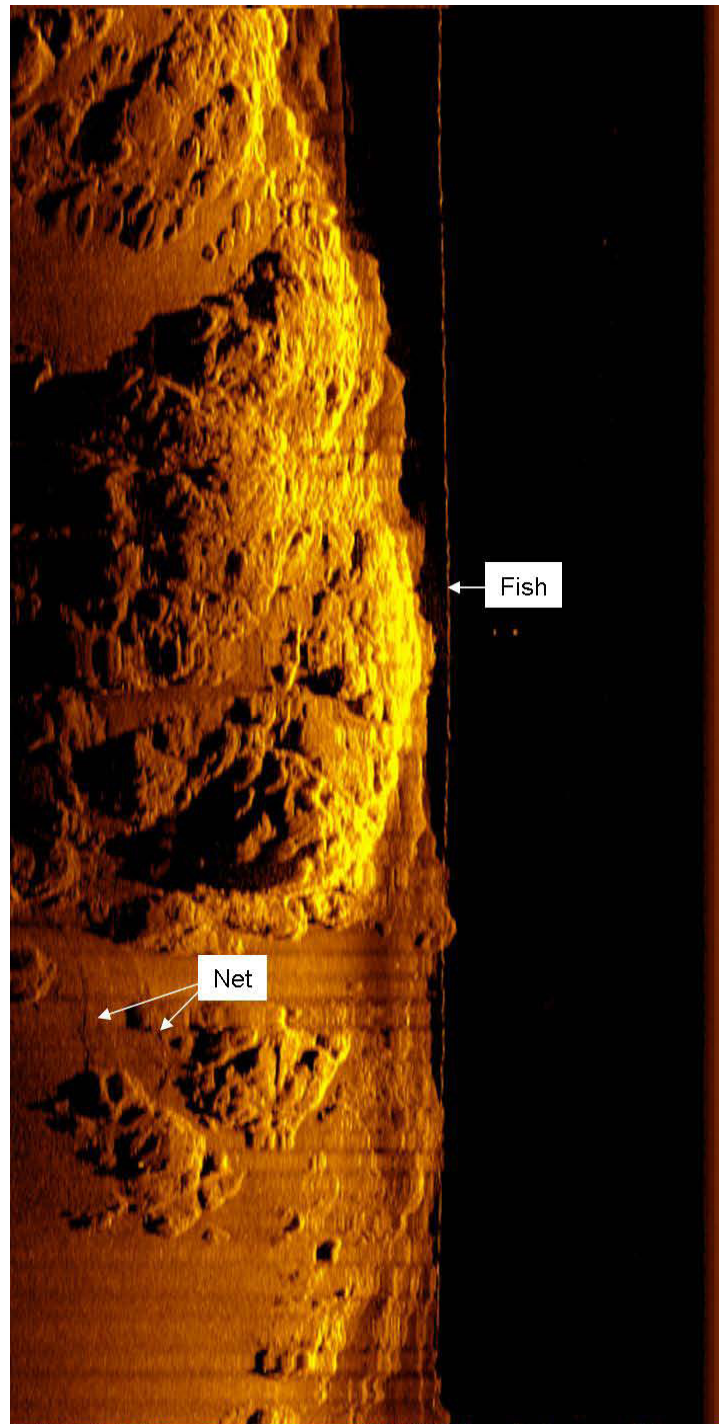
Exhibit 5. Sidescan sonar image showing rockfish habitat, derelict nets and fish aggregations, 2010.

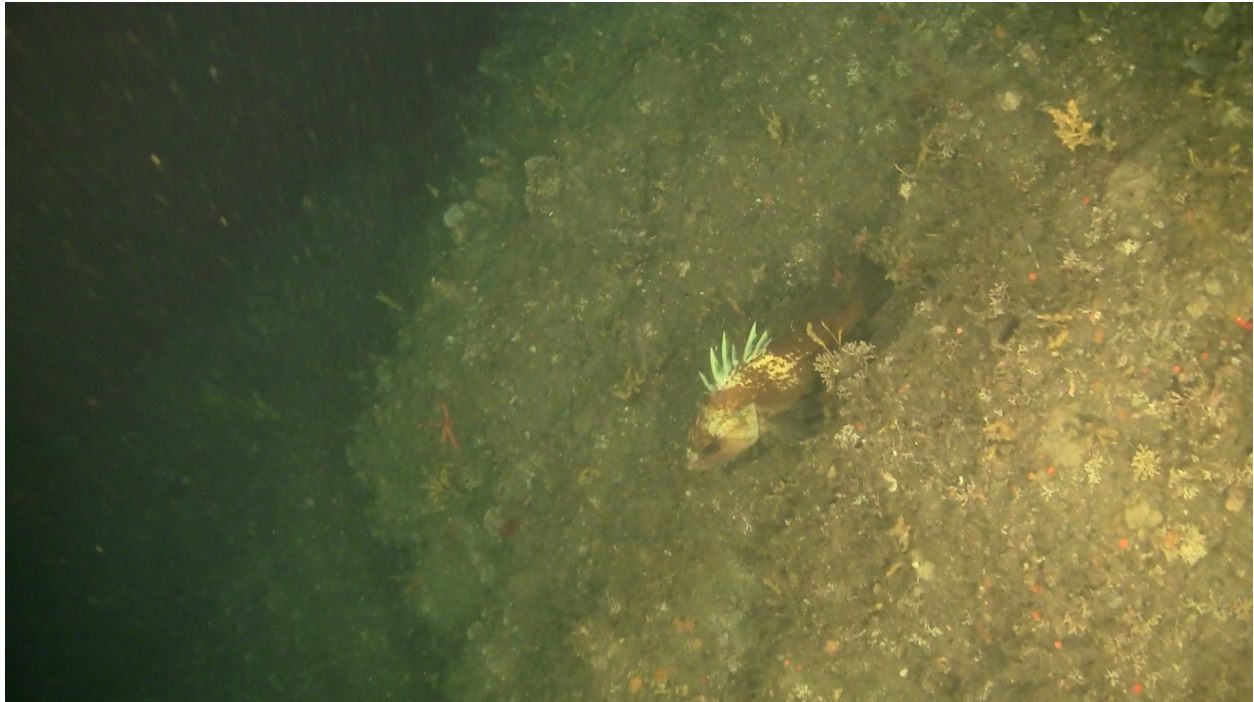
Exhibit 6. An example of a typical image of a rockfish taken in deepwater with a drop camera during the project. The image shows a quillback rockfish, *Sebastes maliger*, on a reef face at 120 feet (36 meters) off the west coastline of San Juan Island.

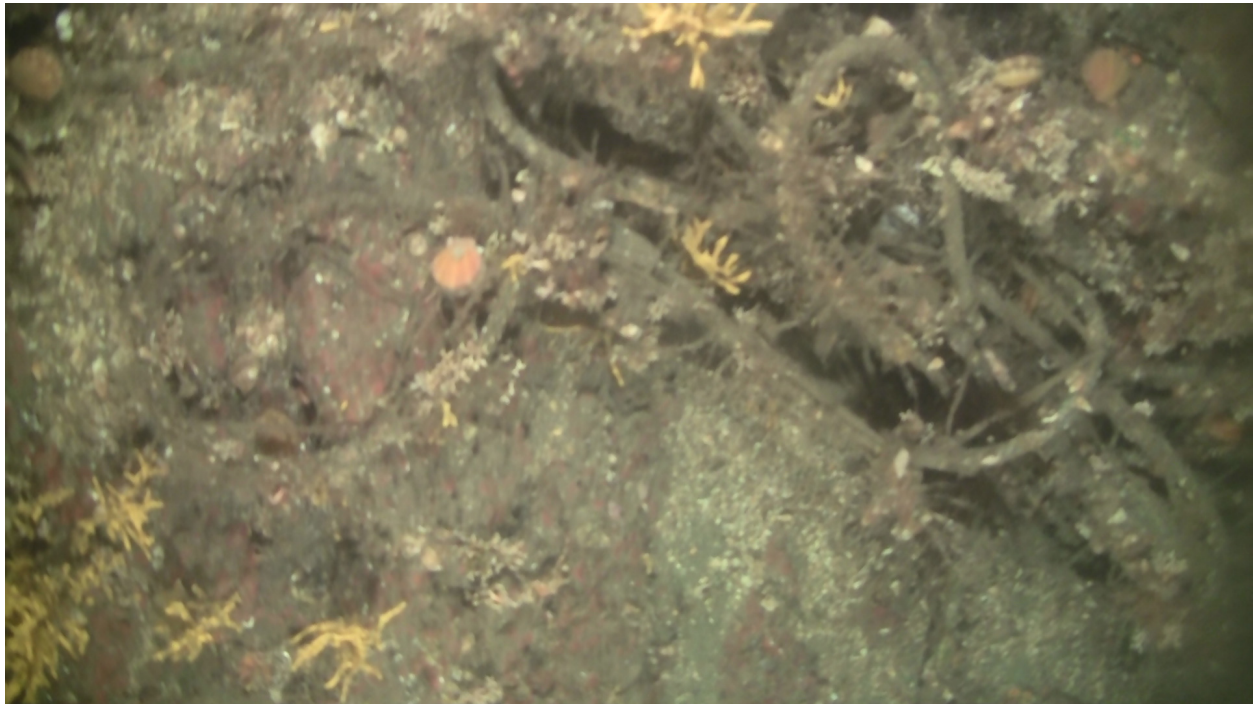
imaging and distinguishing deepwater rockfish habitat as well as derelict fishing gear. Exhibit 7 provides an example of a drop camera image of derelict leadline and scraps of net on a deepwater reef face. Sidescan sonar surveys also proved capable of imaging schools of fish, assumed to be rockfish, congregated at the edge of vertical rock walls (Exhibit 5). Although no rockfish were observed entangled in the derelict net observed during the study, rockfish were observed in the vicinity (300 feet or 100 meters) of the nets at five of the nine target derelict net locations and at two of the target derelict net locations (DG #s 6826/6827 and DW 30), the suspended derelict nets (gillnets) presented a significant risk of entanglement to rockfish and other marine animals.

Exhibit 7. An example of a typical image of derelict gillnet leadline and net scraps taken in deepwater with a drop camera during the project on a reef face at 120 feet (36 meters) off the west coastline of San Juan Island.

Sufficient information on the length, width and configuration of the derelict fishing gear in the habitat was gained during the drop camera survey to prepare a derelict gear removal plan. Although a specific protocol for removal of deepwater derelict nets has yet to be developed and is beyond the scope of this study, the derelict fishing gear encountered during the survey appeared to be capable of removal by one or more ROVs.

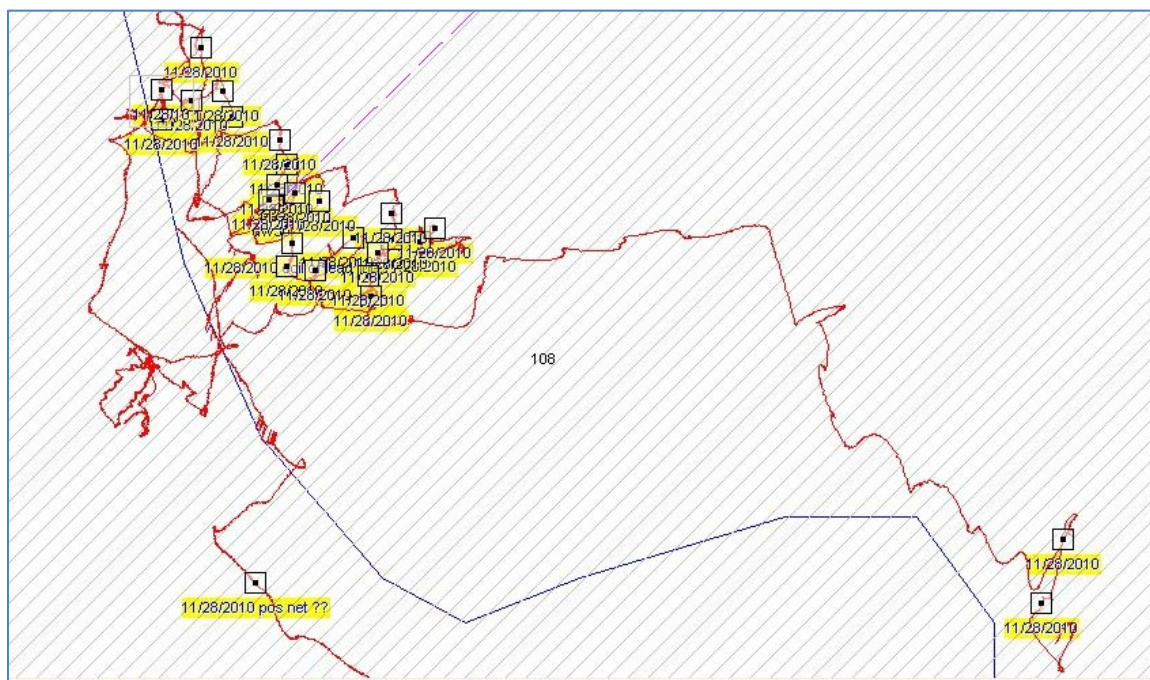
Drop camera survey efforts on November 28, 2010, focused on a derelict net target location, located during the sidescan sonar survey (Gear ID: DW 30 in DG database). Lead line and net were found at this location. In addition, 26 other nets were observed and recorded during the drop camera surveys that were not seen in the sidescan sonar images. The majority of these additional derelict nets were hung up on ridges in the rock and draped down through the valleys, in some places causing suspensions of the net above the seabed. The camera survey also identified an extensive amount of prime rockfish habitat, such as steep rock structures with intermittent valleys and caverns. Lingcod and rockfish were found in close proximity to the derelict nets although no fish were observed entangled in the nets. The survey covered 0.556 nm and 0.001098 nm<sup>2</sup> (Exhibit 4, Appendix A, Figures 10 and 11). Video and still photos from the drop camera surveys are available on DVD.

| Target ID | Gear Type | Min Depth (ft) | Max Depth (ft) | Investigation Status | Location | Latitude | Longitude | Date of Drop Camera Investigation | Additional Targets Found | Habitat type | Rockfish Habitat | Rockfish Present | Rockfish Risk | Comments |
|---|---|---|---|---|---|---|---|---|---|---|---|---|---|--|
| dw30 | Gillnet | 115 | 220 | Net Found | Eagle Point | 48 27.550 | 123 02.500 | 11/28/10 | 26 | Large Rock Structure with sand/shell base | Yes | Yes | High | Rockfish, lingcod, kelp greenling, Puget Sound king crab, red sea urchins, sea cucumbers |

Figure 10: Date: 11/28/10 Target: DW30

Track line length: 0.556 nm (3,378 ft.)

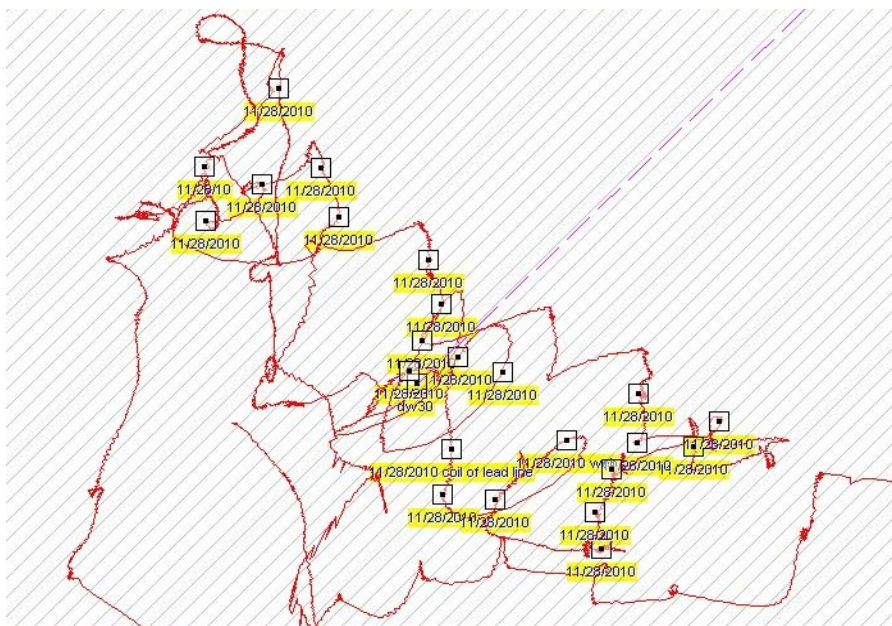
Figure 11: Close-up of additional derelict gear targets identified with the drop camera at DW30.
