FINAL REPORT

KING COUNTY 2009 DERELICT FISHING GEAR MONITORING PROJECT

NORTHWEST STRAITS INITIATIVE
AND
KING COUNTY METRO

December 11, 2009

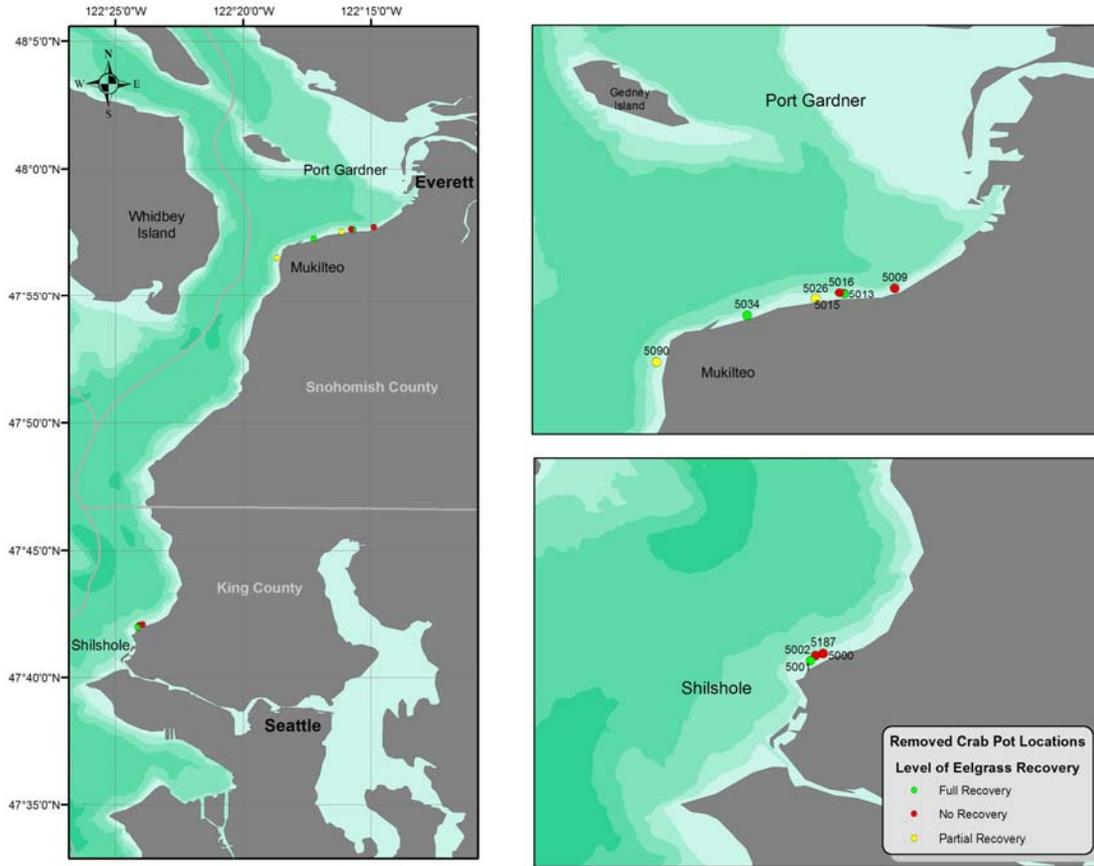
Figure 1. The location and relative recovery of eelgrass of eleven derelict crab pots removed from Puget Sound.

Full recovery of eelgrass from derelict pot impacts occurred at three of the eleven (27%) pot removal locations, one location near Shilshole and two locations in Port Gardner (Table 1 and Figure 1). There was partial recovery of eelgrass at two of the eleven (18%) pot removal locations in Port Gardner. Six of the eleven (55%) of the pot removal locations, three near Shilshole and three in Port Gardner, showed no recovery of eelgrass one-year after pot removal (Table 1 and Figure 1). Divers reported derelict pot footprint marks were not evident at any of the eleven derelict pot removal locations.

Divers reported that eelgrass has receded from the derelict pot removal locations in three locations near Shilshole (pots 5000, 5001 and 5187) and two locations in Port Gardner (pots 5013 and 5016) (Table 1 and Appendix 1). The bottom substrate appeared to be generally disturbed throughout these areas and remaining eelgrass was broken, uncovered or generally in poor condition.

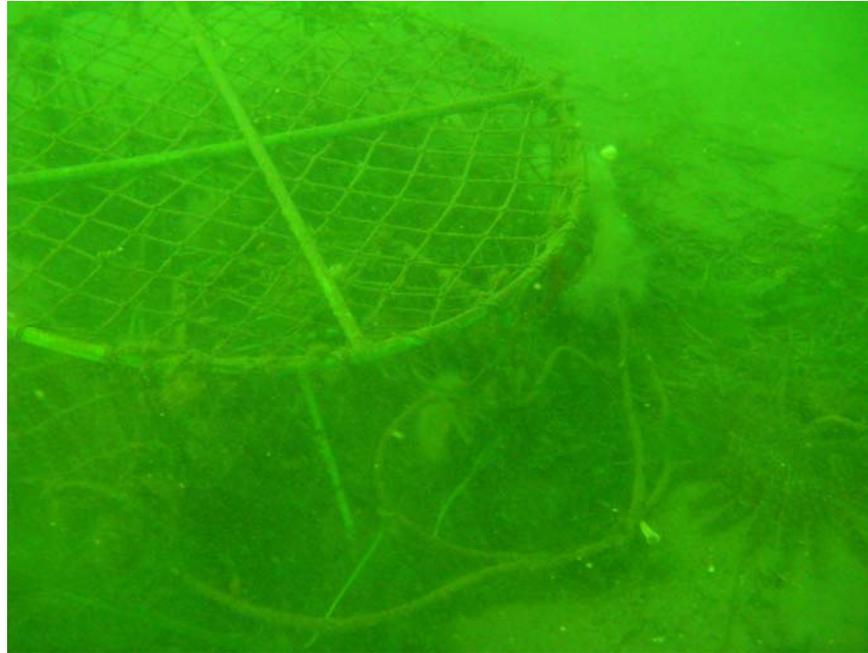
Pot 5000
Pre-Removal

Sparse eelgrass in the area within 3 ft of pot location.

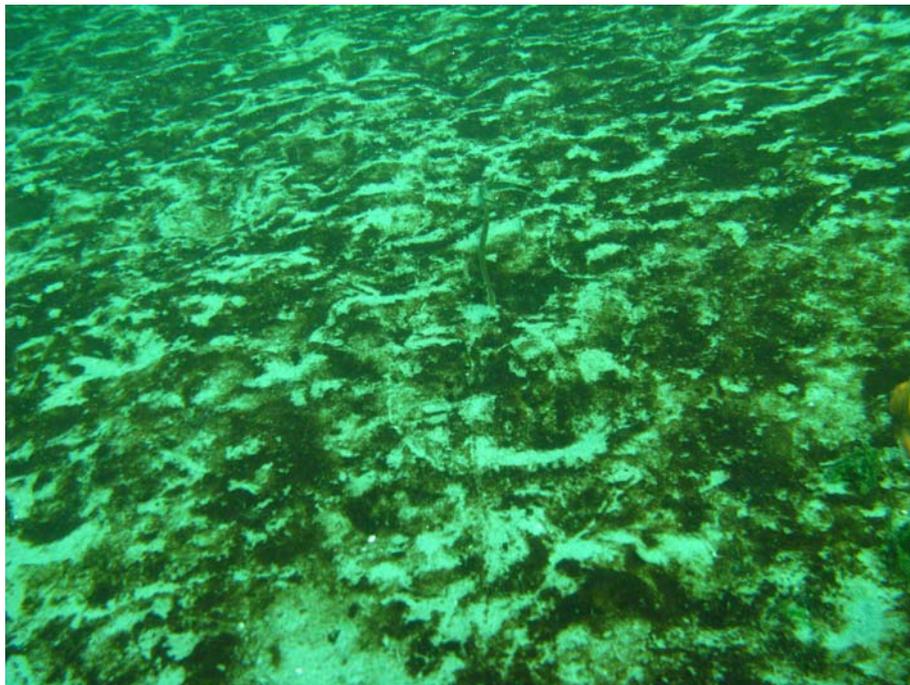
One Year Post-Removal

| Crab Pot ID | General Location | Latitude | Longitude | MLLW Depth (ft) | Habitat Type | Pre-Removal Eelgrass Condition | Post-Removal Eelgrass Condition | Eelgrass Recovery Index |
|---|---|---|---|---|---|--|---|---|
| 5000 | Shilshole | 47°42.07' N | 122°23.94'W | 26 ft | Sand | Sparse Eelgrass | Sparse eelgrass within 12 ft shoreward, bottom covered with macroalgae at pot location | No Recovery |

Eelgrass edge was 12 ft inshore of pot location. Pot location covered with macroalgae on sand. Eelgrass edge has apparently receded toward shore 9 ft from pot location.

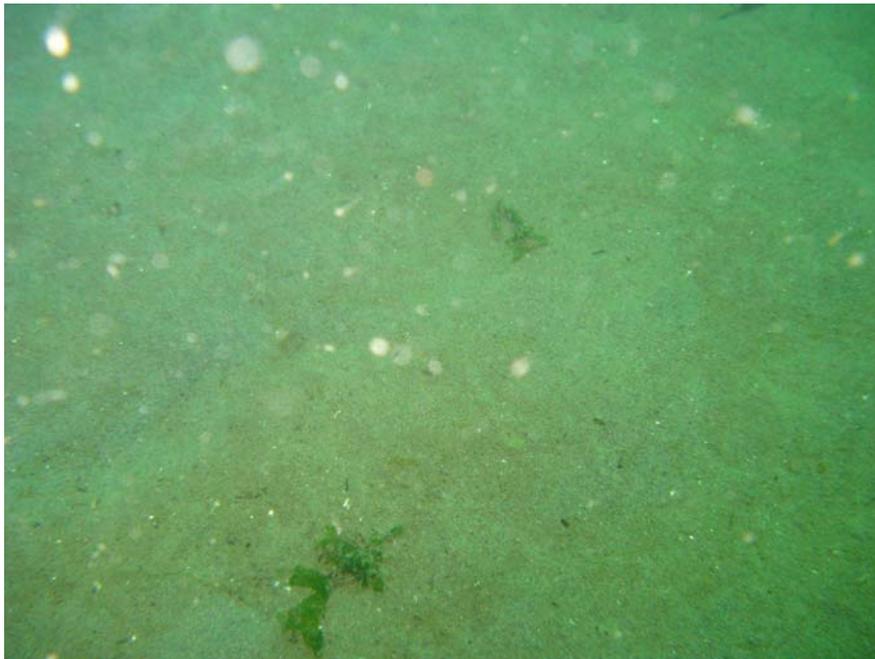
One Year Post-Removal

| Crab Pot ID | General Location | Latitude | Longitude | MLLW Depth (ft) | Habitat Type | Pre-Removal Eelgrass Condition | Post-Removal Eelgrass Condition | Eelgrass Recovery Index |
|---|---|---|---|---|---|--|---|---|
| 5001 | Shilshole | 47°42.04' N | 122°24.06'W | 30 ft | Sand | Sparse Eelgrass | Sparse eelgrass within 20 ft shoreward | No Recovery |

No eelgrass with 20 ft of pot location. Sparse eelgrass apparently receded from pot location.

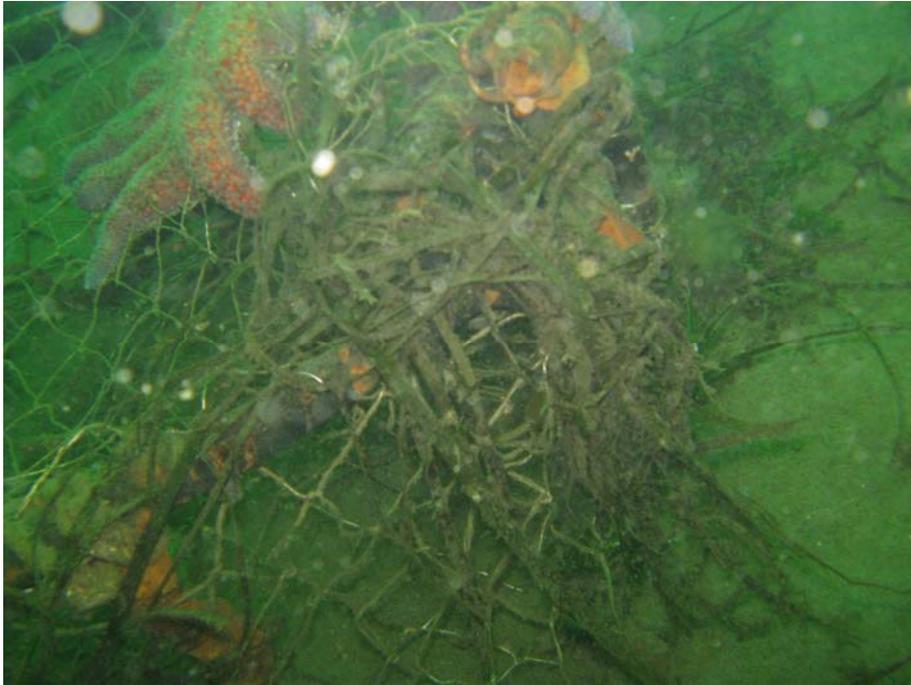
Pot 5002
Pre-Removal

Medium-high density eelgrass at crab pot location.

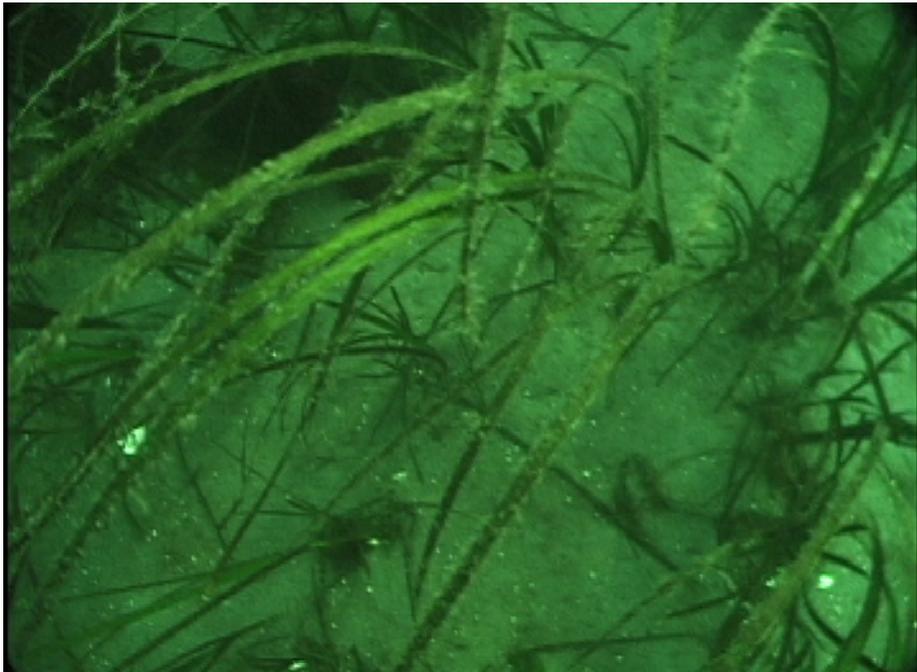
One Year Post-Removal

Medium-high density eelgrass at crab pot location, full recovery.

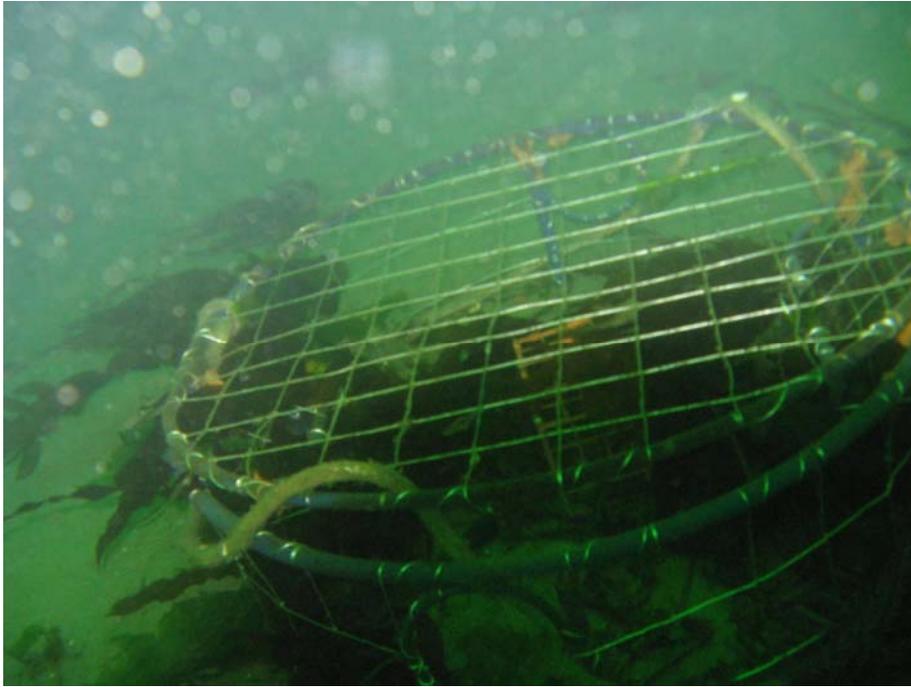
Pot 5009
Pre-Removal

Thick eelgrass in the area within 8 ft of pot location on top of slope edge in 31 ft of water.

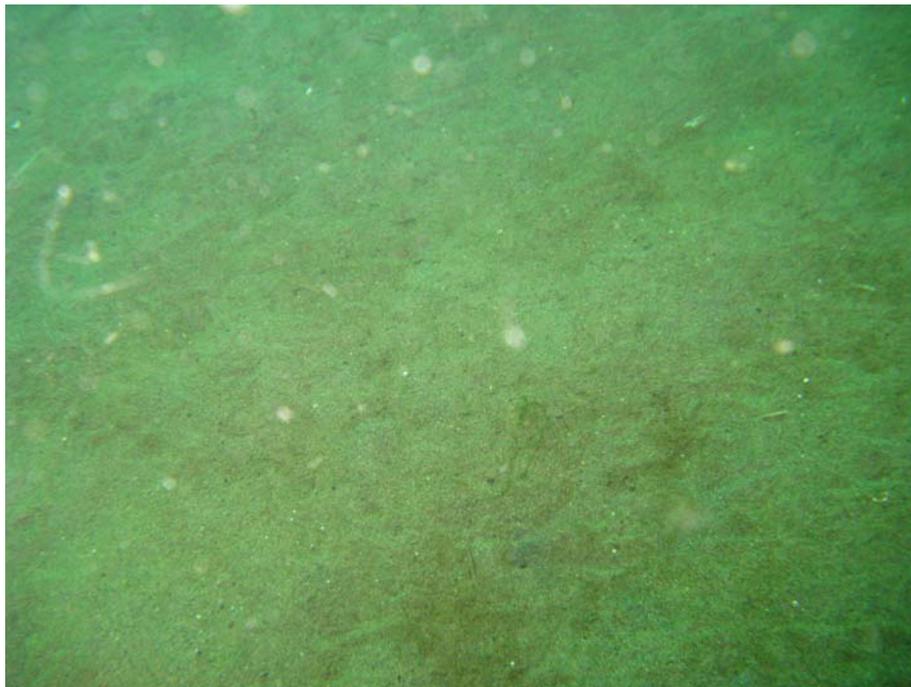
One Year Post-Removal

No eelgrass growth observed at former pot location; eelgrass edge in same location and density.

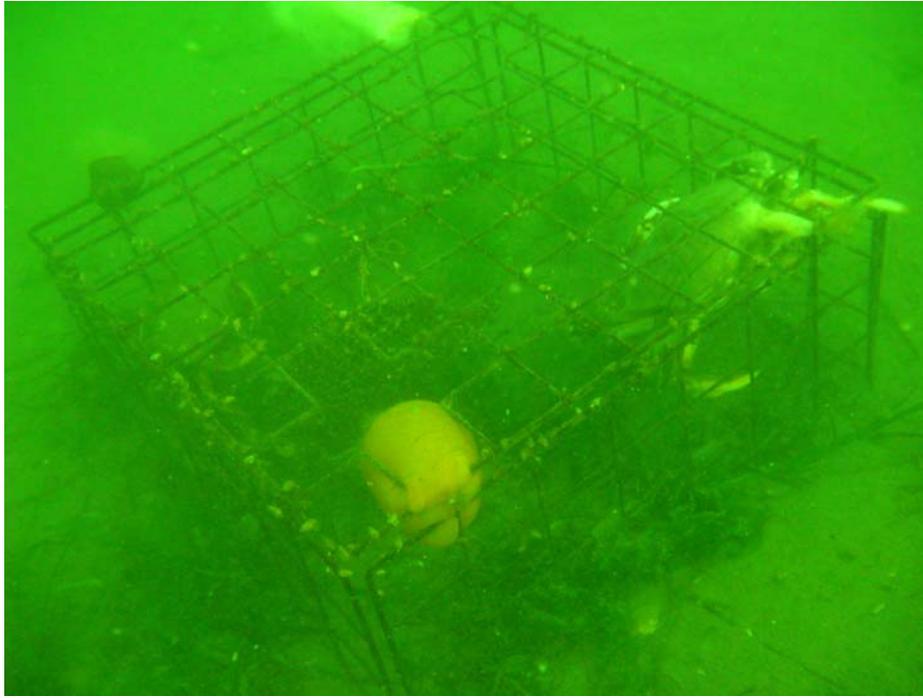
Pot 5013
Pre-Removal

Sparse eelgrass in the area

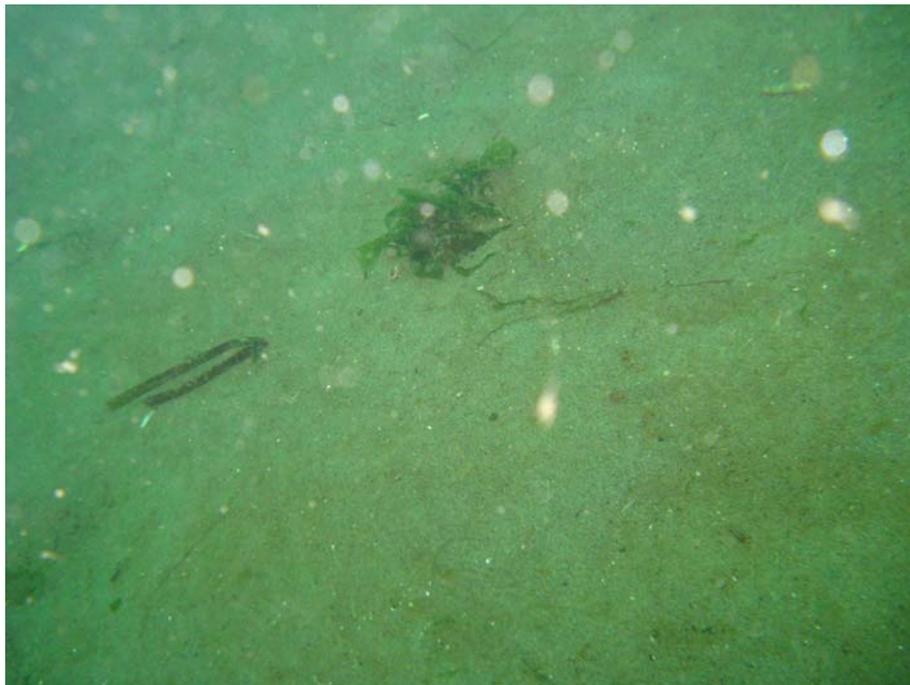
One Year Post-Removal

Very little eelgrass in the vicinity of the pot location, sparse eelgrass edge within 12 ft at -22 ft MLLW of water depth along entire area. Remnant eelgrass plants in area. Eelgrass apparently receded about 12 ft from pot location.

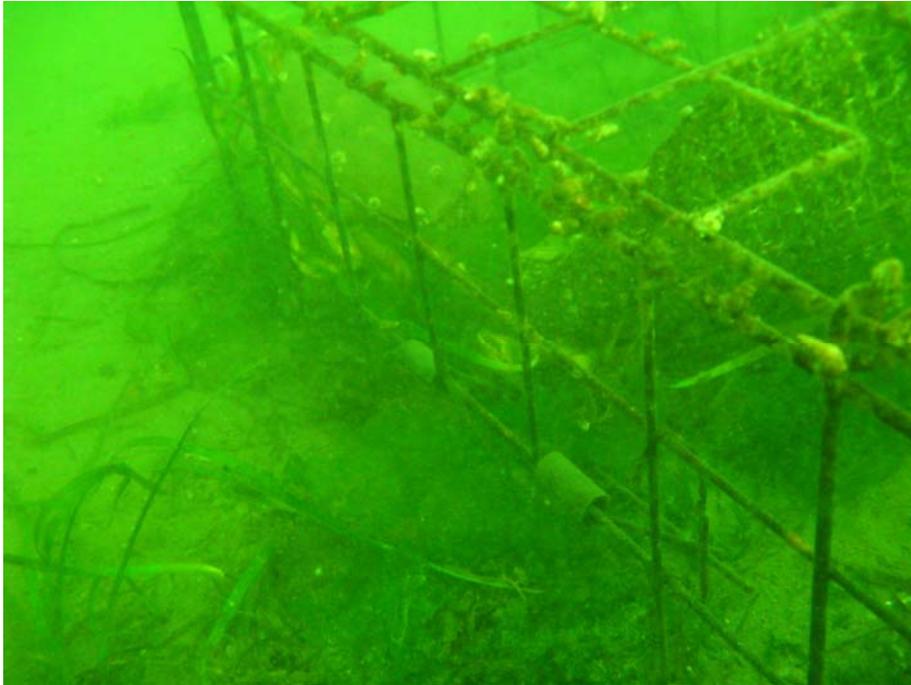
Pot 5015
Pre-Removal

Sparse eelgrass in the area

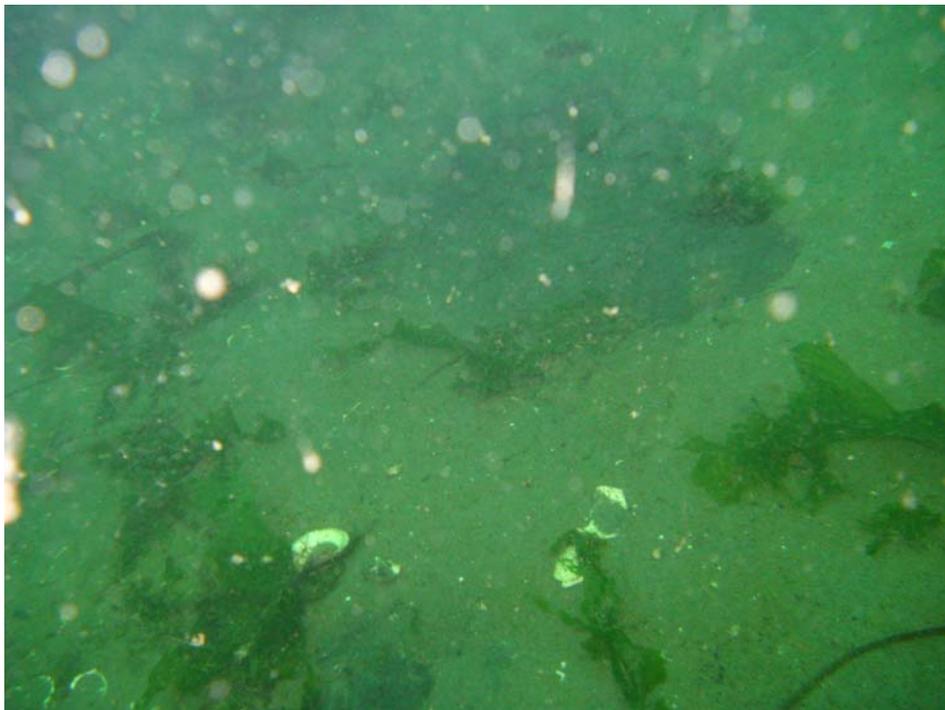
One Year Post-Removal

Sparse eelgrass remained in the area, pot location was not obvious, probably 100% eelgrass recovery.

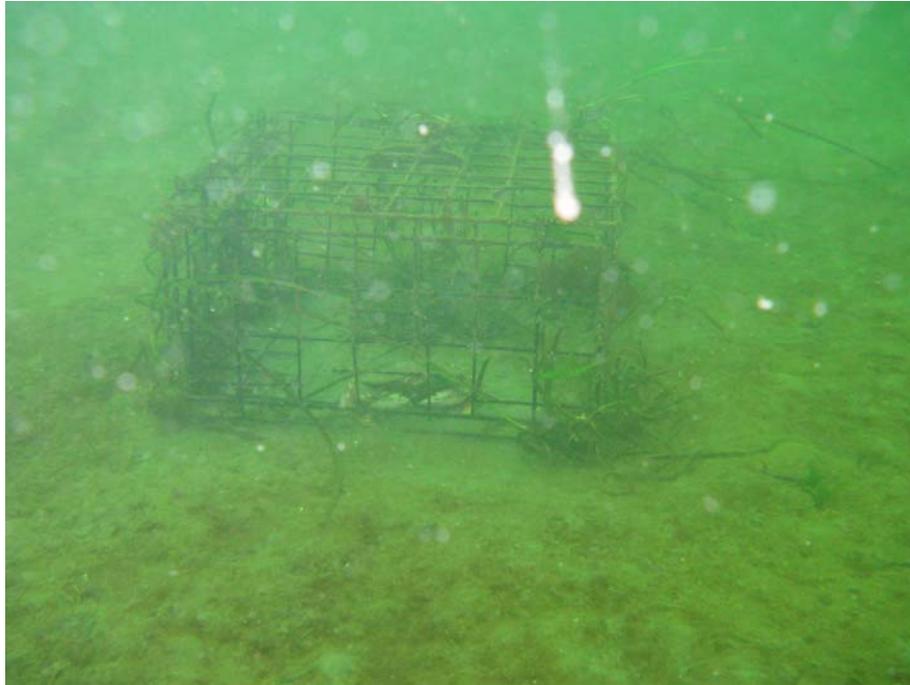
Pot 5016
Pre-Removal

Sparse eelgrass in the general area around the pot, eelgrass edge within 6 ft inshore.

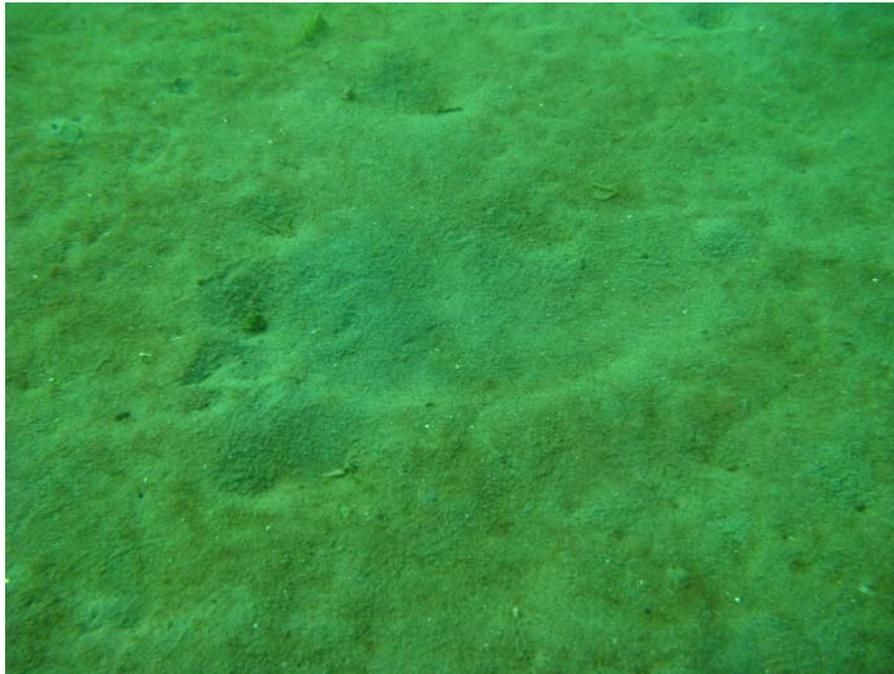
One Year Post-Removal

No eelgrass in the vicinity of the pot location, sparse eelgrass edge within 6 ft at -26 ft MLLW depth along entire area.

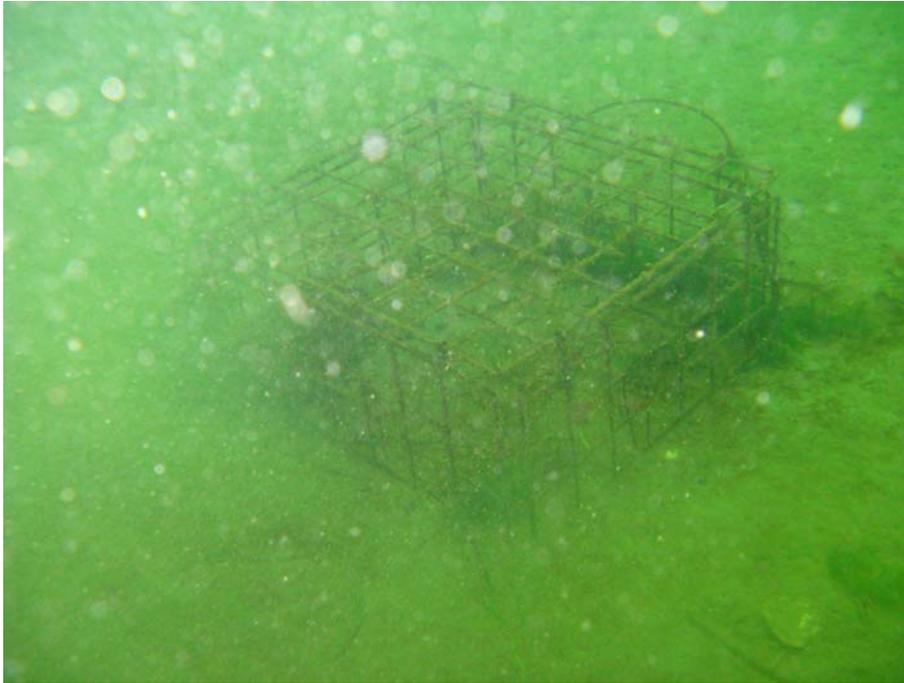
Pot 5026
Pre-Removal

Sparse eelgrass in the general area around the pot, eelgrass edge within 6 ft inshore.

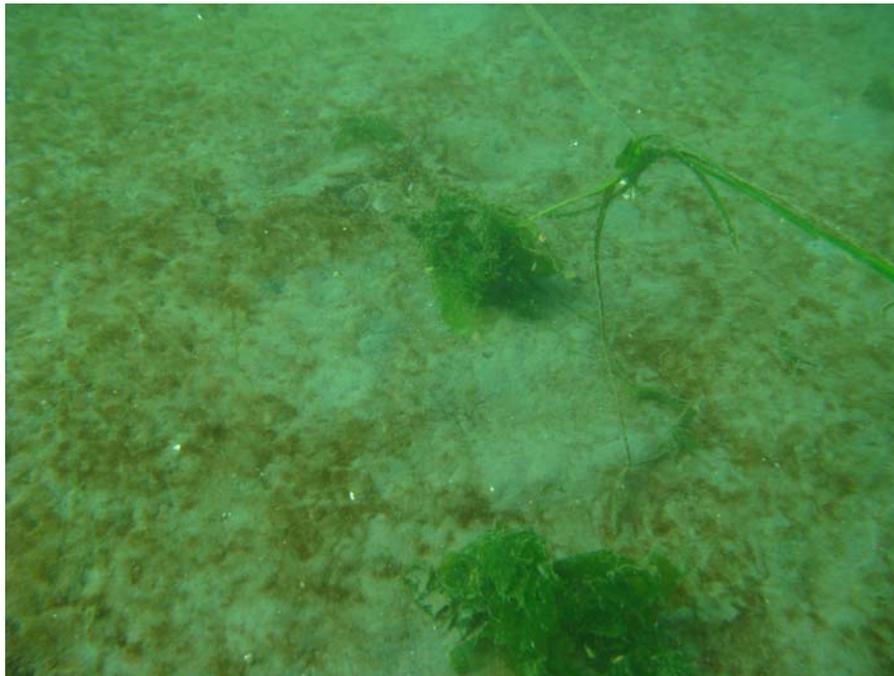
One Year Post-Removal

Some eelgrass in the vicinity of the pot location, thicker eelgrass edge within 6 ft of pot location at -11 ft MLLW depth along entire area. Eelgrass edge appears to have extended out 3 ft further from shore than when pot was removed. Some signs of eelgrass recovery at pot location.

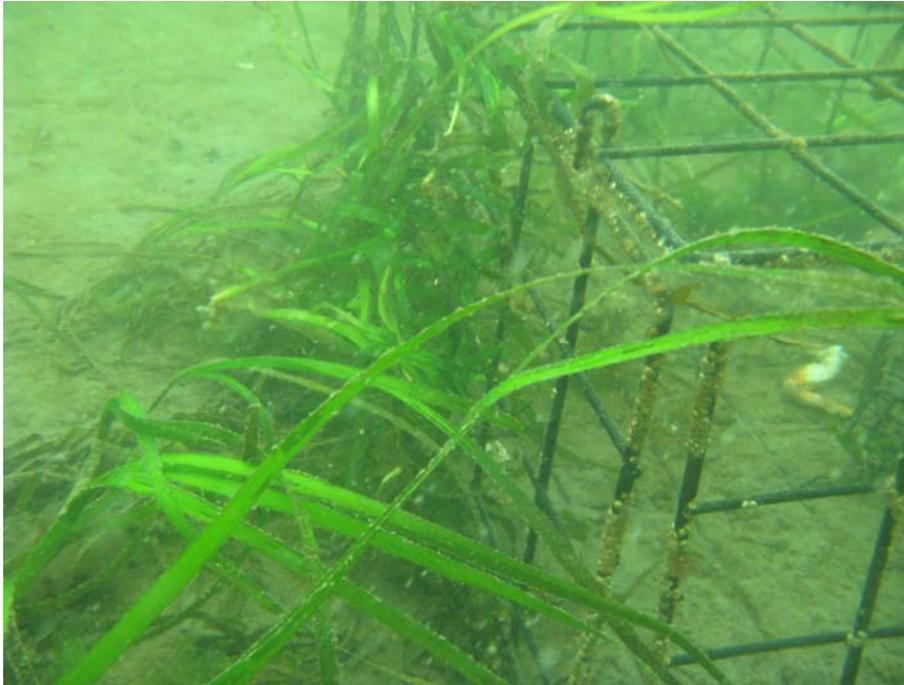
Pot 5034
Pre-Removal

Medium density eelgrass throughout the area.

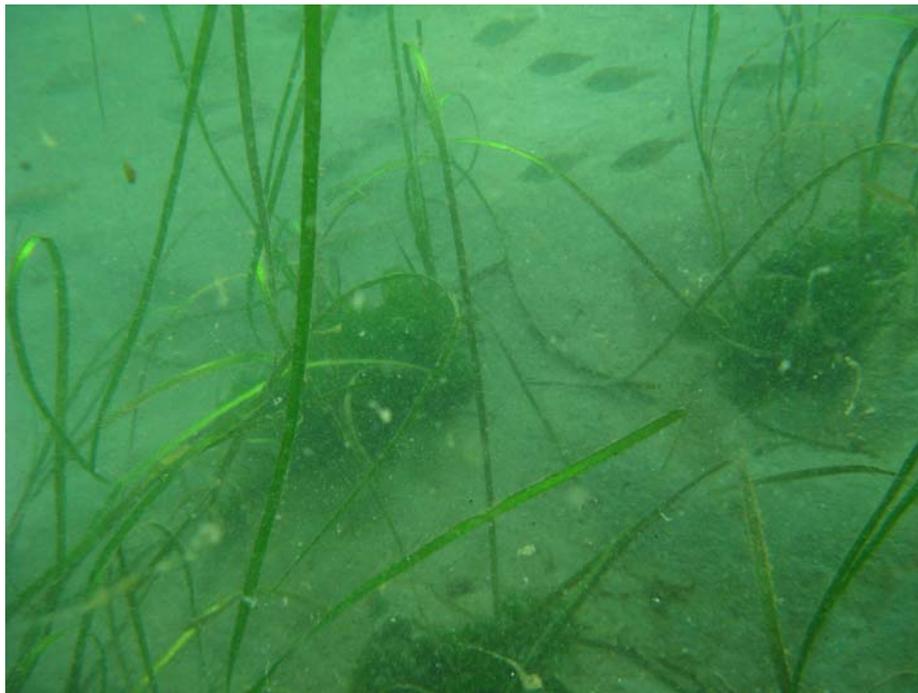
One Year Post-Removal

Medium density eelgrass throughout the area, crab pot footprint fully recovered.

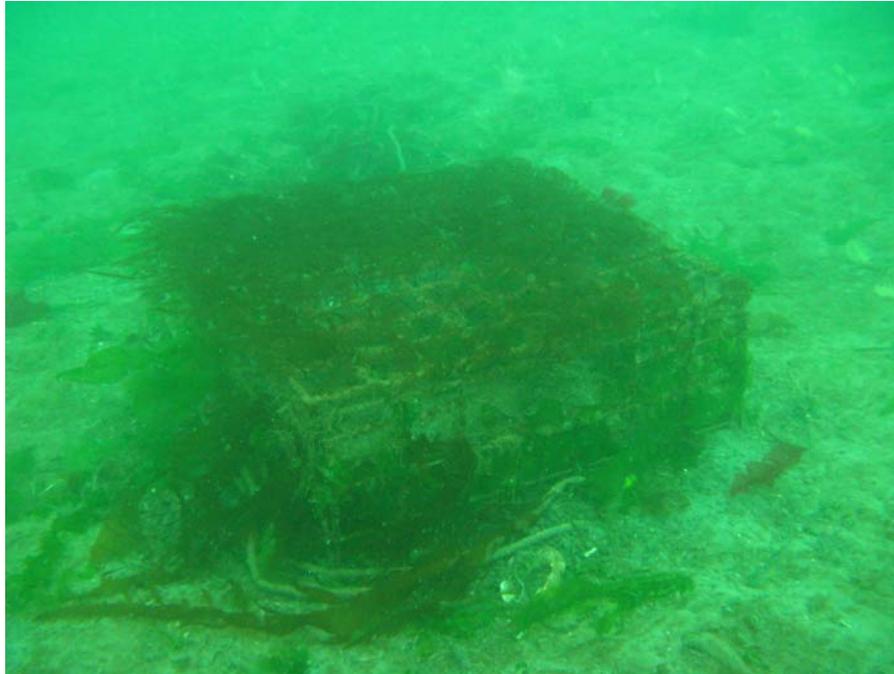
Pot 5090
Pre-Removal

Medium density eelgrass within 20 ft of crab pot location.

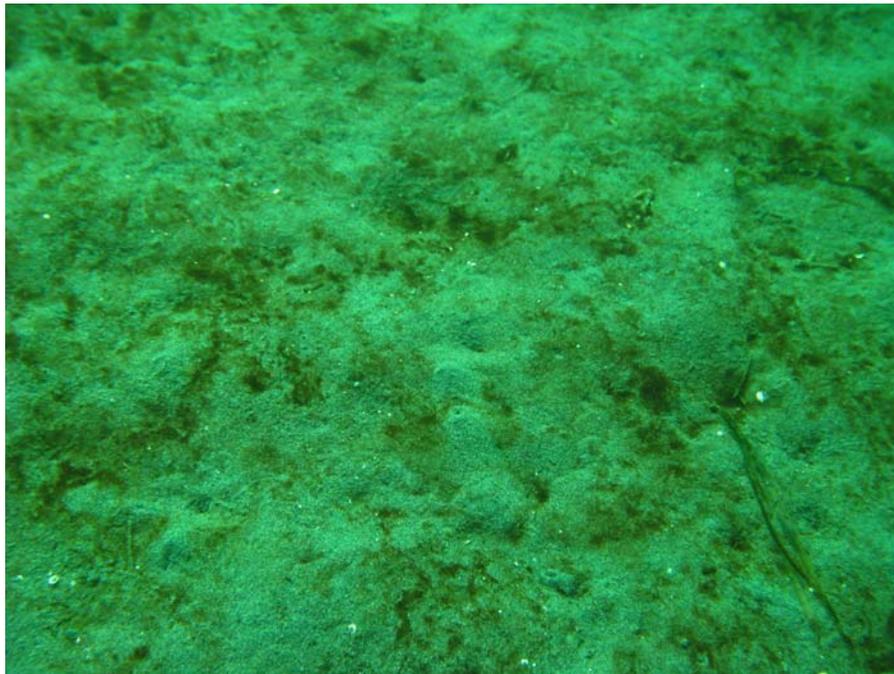
One Year Post-Removal

Medium density eelgrass within 10 ft of crab pot location. No eelgrass at pot location. Eelgrass edge appears to have extended out 10 ft further from shore than when pot was removed. Some macroalgae at pot location.

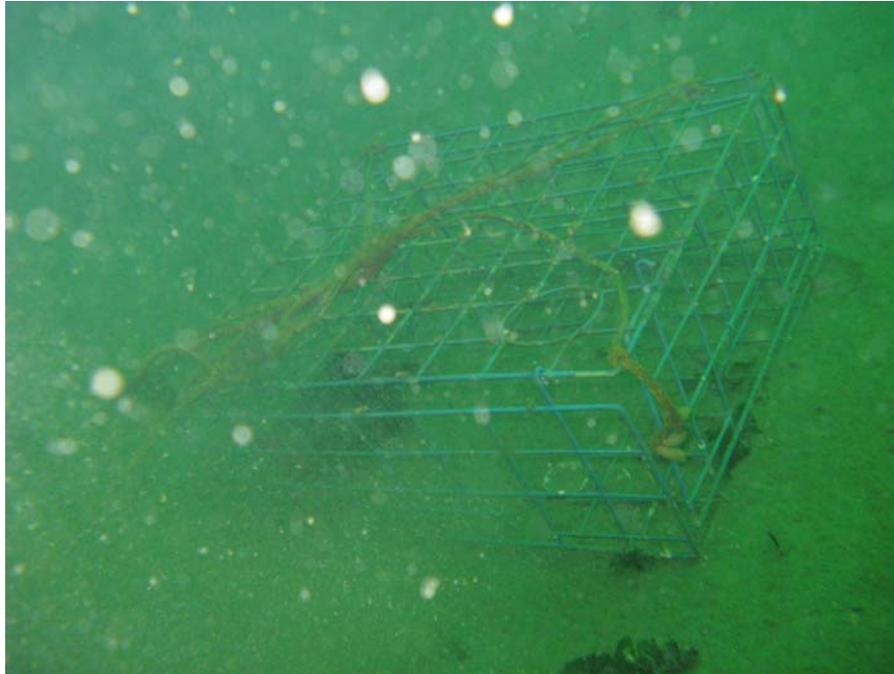
Pot 5187
Pre-Removal

Sparse eelgrass at crab pot location.

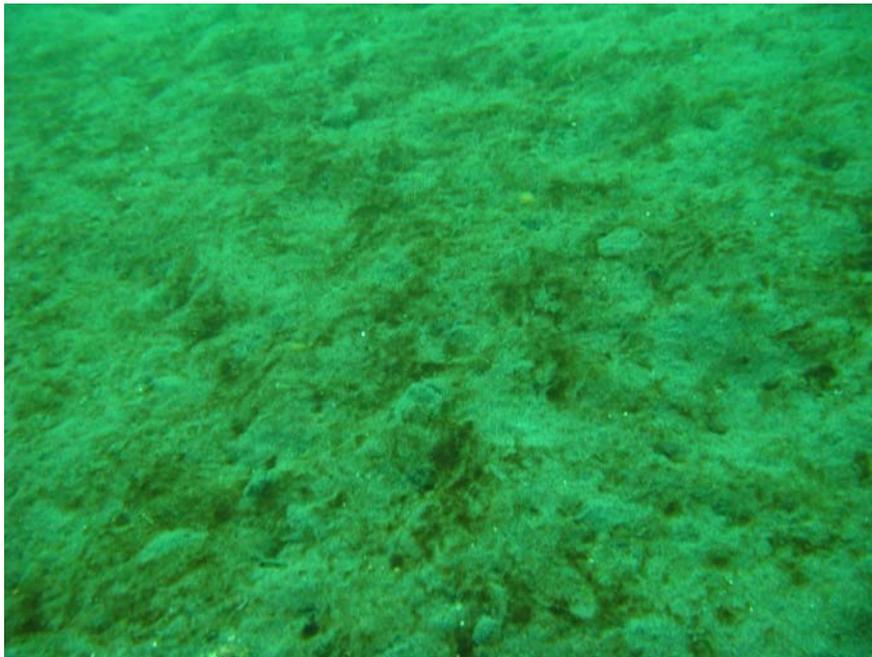
One Year Post Removal

No eelgrass with 20 ft of pot location. Sparse eelgrass apparently receded 20 ft toward shore from pot location. Some macroalgae at pot location.
