Hoypus Point and Possession Point Restoration

Feasibility Report

Island County Marine Resources Committee and Northwest Straits Foundation

June 25, 2020

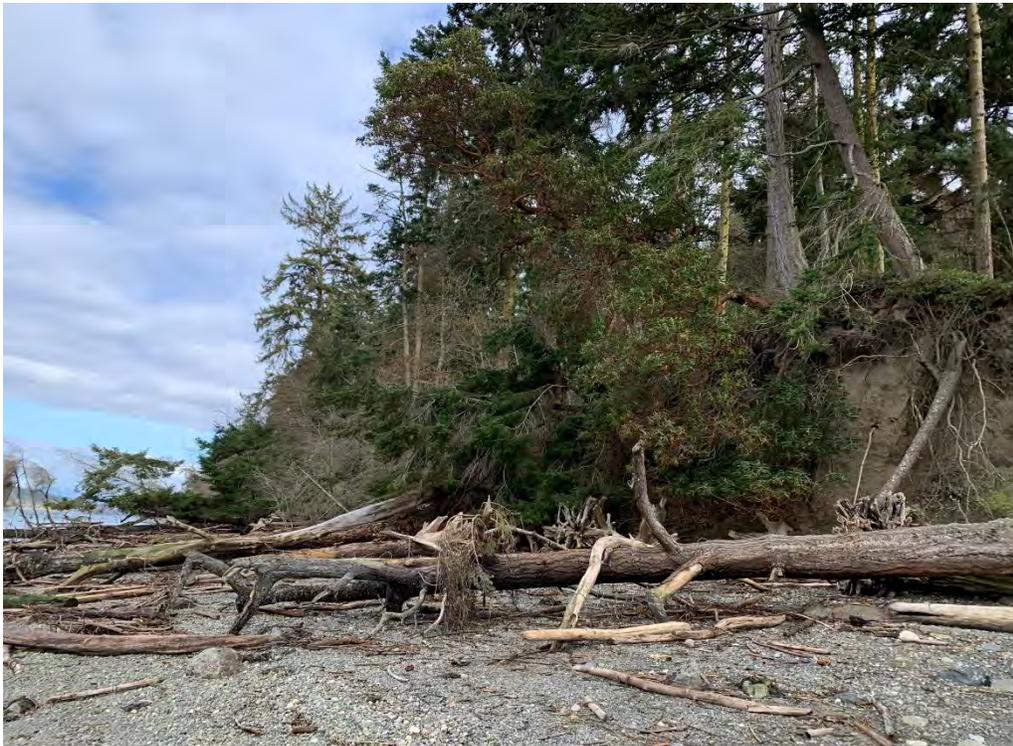
The uplands at Hoypus Point are characterized by forested steep slopes which are sources of sediment and large woody debris (LWD) to the adjacent beaches (Figures A2 and B4). There is also a mapped feeder bluff updrift and to the east of the project area. Littoral drift is generally from east to west in the vicinity of the project area. Sediment grain size distributions on the beach are medium to coarse sand with small amounts of gravel (Figure A3). To the southeast of the project site is a wide low-tide terrace consisting of fine-grained sediments. The wide low-tide terrace was formed by a deep-seated slide of the upland slope as described in section 2.1.3 which deposited a large volume of sediment along the shoreline.

Figure A-2. Accumulation of large woody debris, west of Hoypus Point.

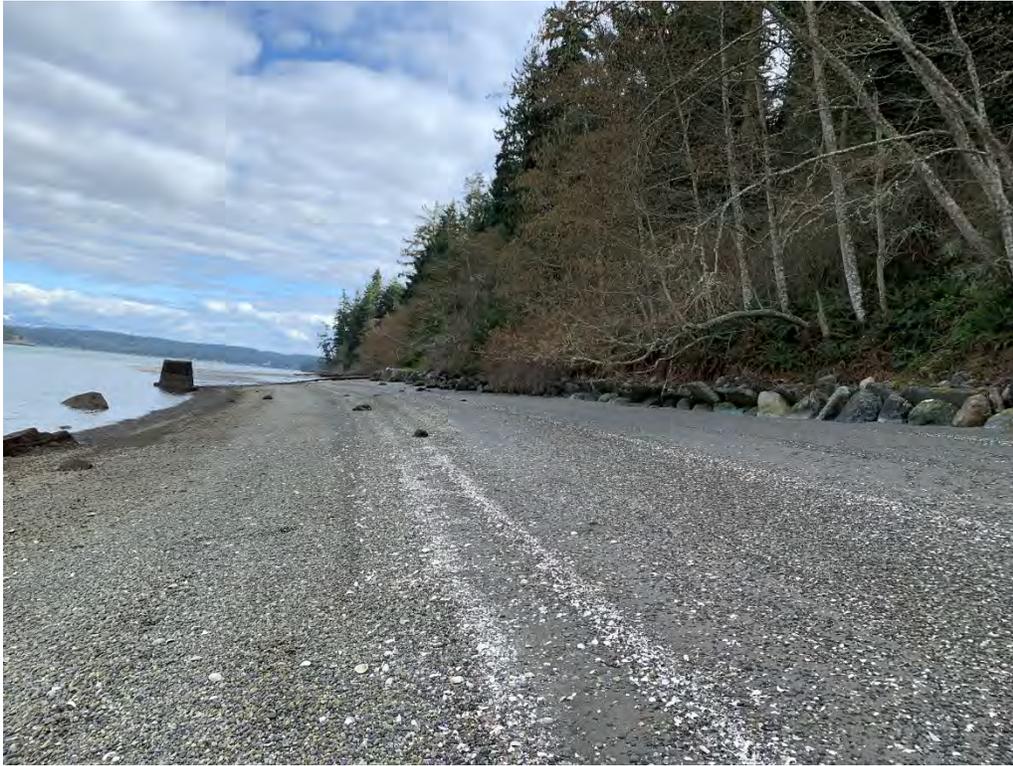
Figure A-3. Looking east from the start of armoring, abutment is visible on left.

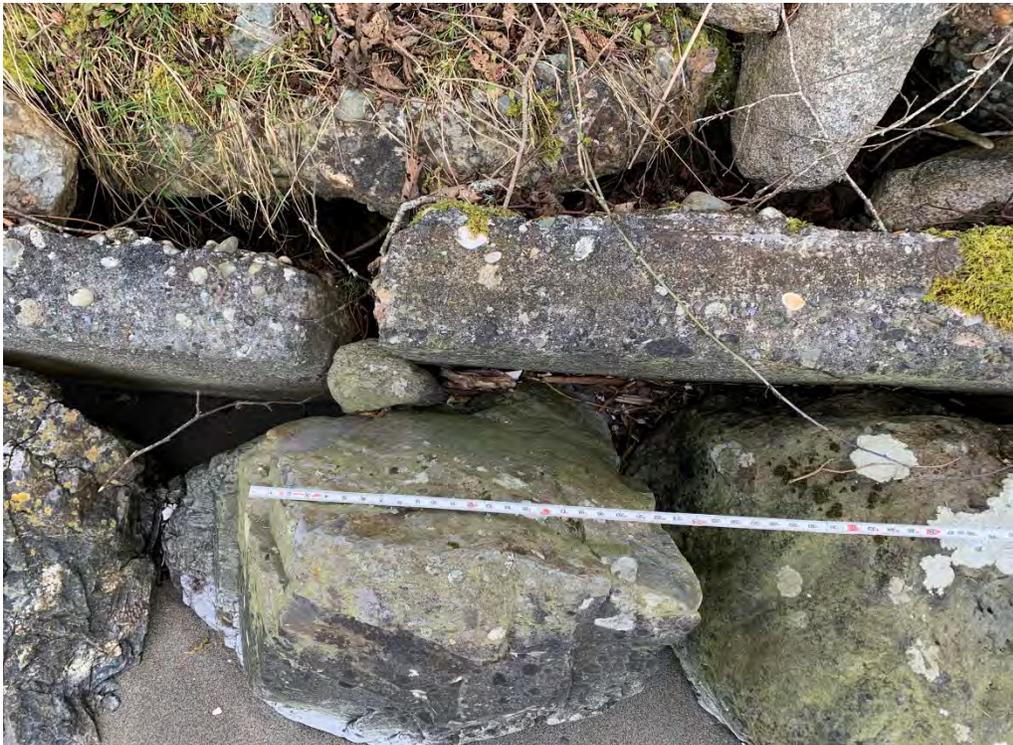
Figure A-4. Example of armoring along the shoreline.

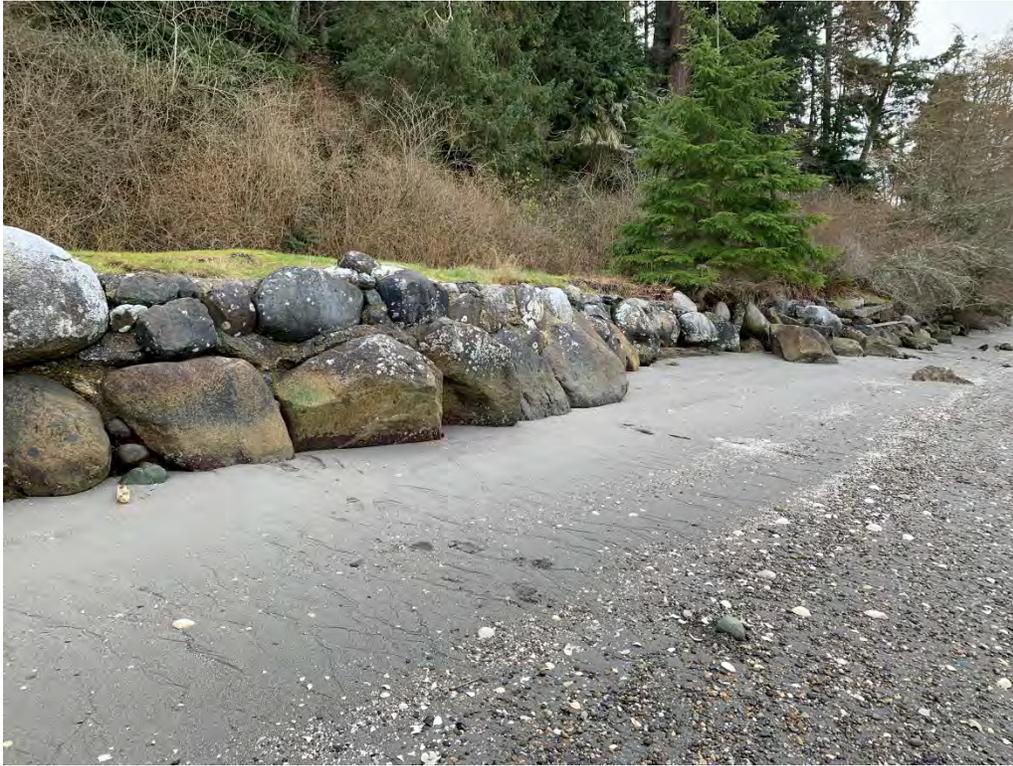
Figure A-5. Looking west towards the large flat area and along armorment.

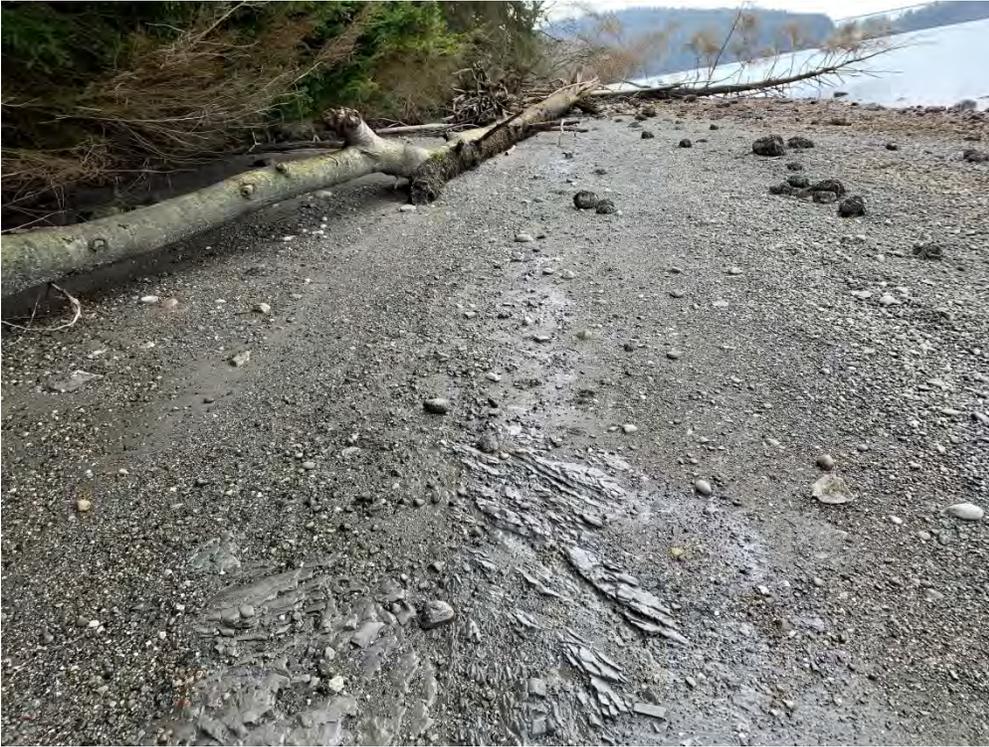
The shoreline and beach immediately southwest of the project site is mapped as Vashon Stade silt and clay deposits which have thin to thick bedded clay, silt, and silty sand. This unit is a consolidated material that has a very low permeability and can result in surface water and groundwater flow being perched on top of these sediments. The presence of clay layers and perched groundwater can result in erosion of mixed sand and gravel from the beach surface. This was observed to the southwest of the Project Area at Hoypus Point, but not within the Project Area (Figure A7).

Figure A-7. Clay sediments on the beach between Hoypus Point and Cornet Bay.

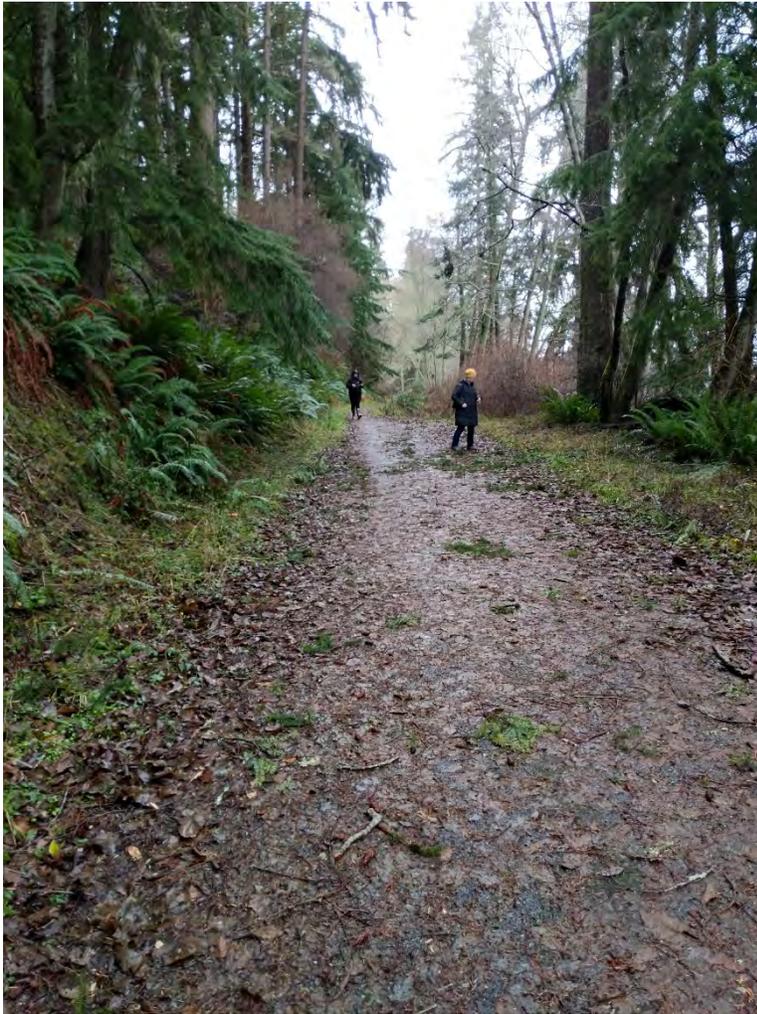
Figure A-8. The road/trail, person farthest back is alongside the slump on the trail.

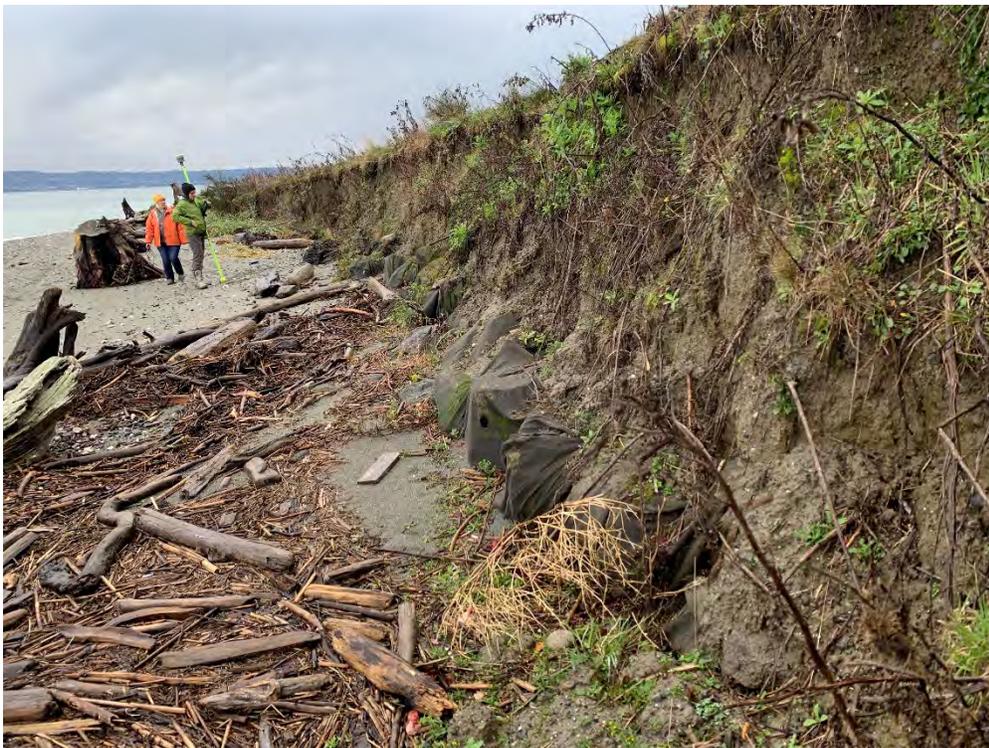
Between 2011 and 2012 a shoreline armoring replacement project was completed by PND Engineers (Figure B7). The project removed a deteriorating 430-foot creosote timber pile bulkhead and concrete boat ramp and stairs. The bulkhead was replaced with a 480-foot-long buried rock revetment, located slightly landward from the previous shoreline structure. Armor rocks that were placed were covered with a geotextile, which is now exposed, mainly on the northern side of the property. During the project, a 160-foot section of 6-inch diameter stormwater pipe was replaced with 12-inch diameter high-density polyethylene (HDPE) pipe and buried 24 inches. A stormwater energy dissipater was also installed in the southern end of the rock revetment, landward of MHHW as described in the Shoreline Substantial Development Permit for the project (see Figure B7). An energy dissipater is a section of pipe with holes that allow water flow to spread over a larger area, reducing the chance for scour. This structure is still likely functioning as designed as there are no distinct areas of erosion coming from the buried revetment that appear to be caused by stormwater flow.

Figure A-9. Looking south at erosion and exposed geotextiles.

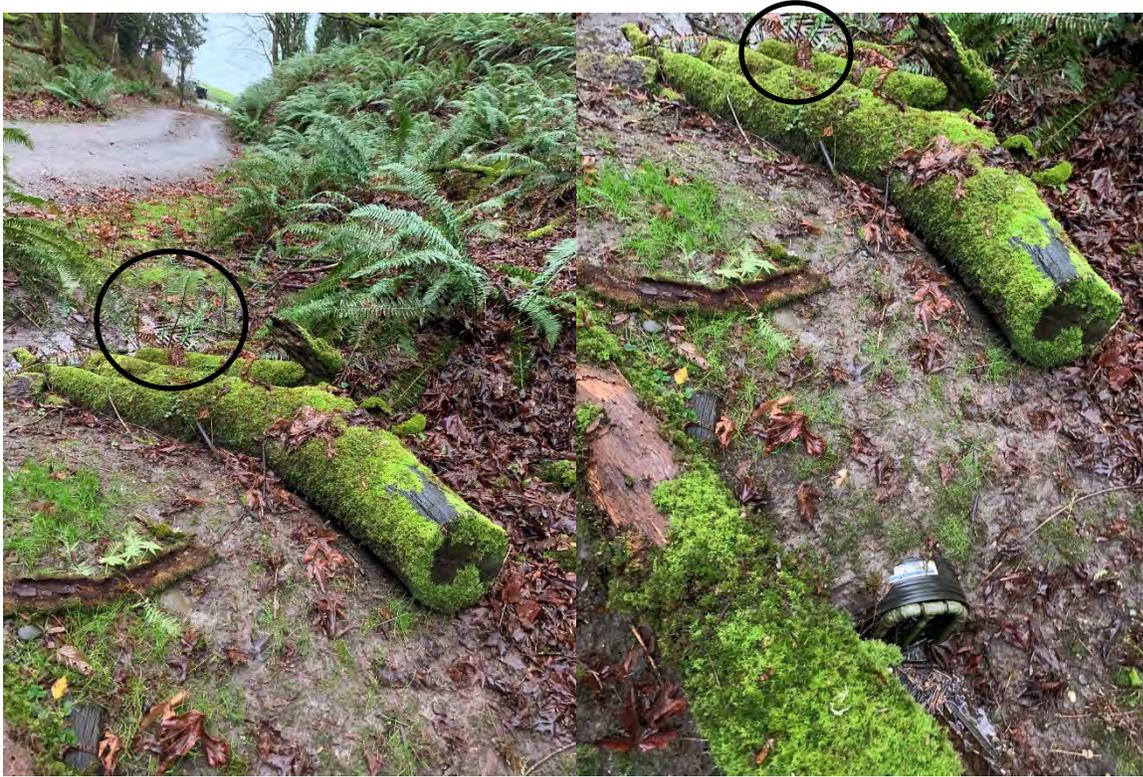
Figure A-14. Photo of southern upland drainage, the circle indicates the position of the same stormwater grate.

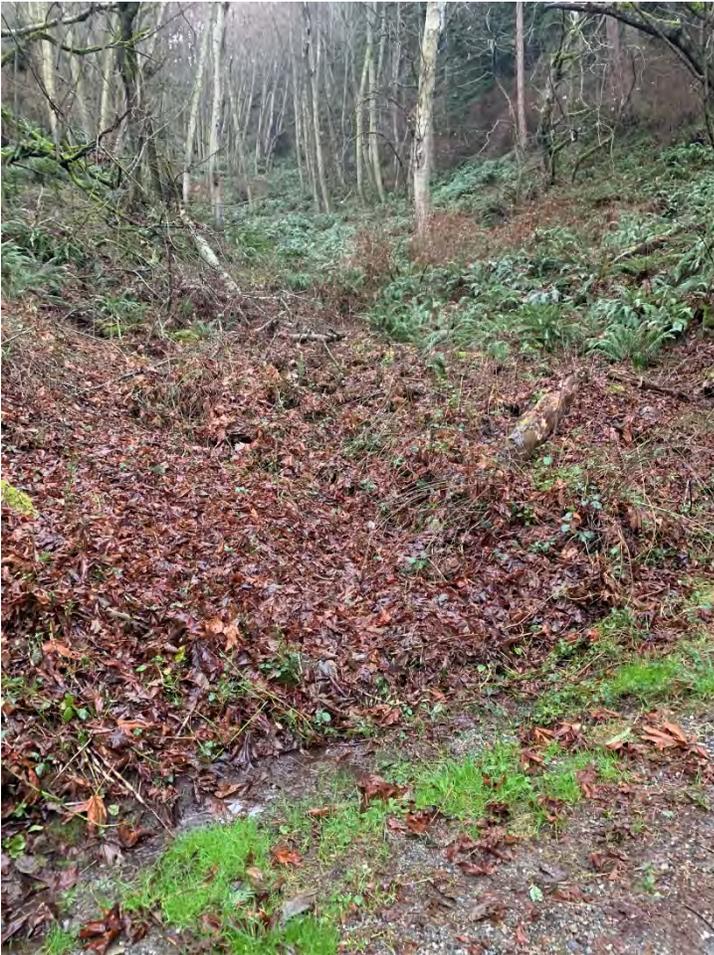
Figure A-15. Photo of northern upland drainage, looking upstream. Water is flowing in a ditch west side of the access road.
