Hidden Beach Armor Removal and Restoration Preliminary Design Report

Prepared for Lisa Kaufman, Northwest Straits Foundation

Prepared by Coastal Geologic Services, Inc.

April 4, 2019

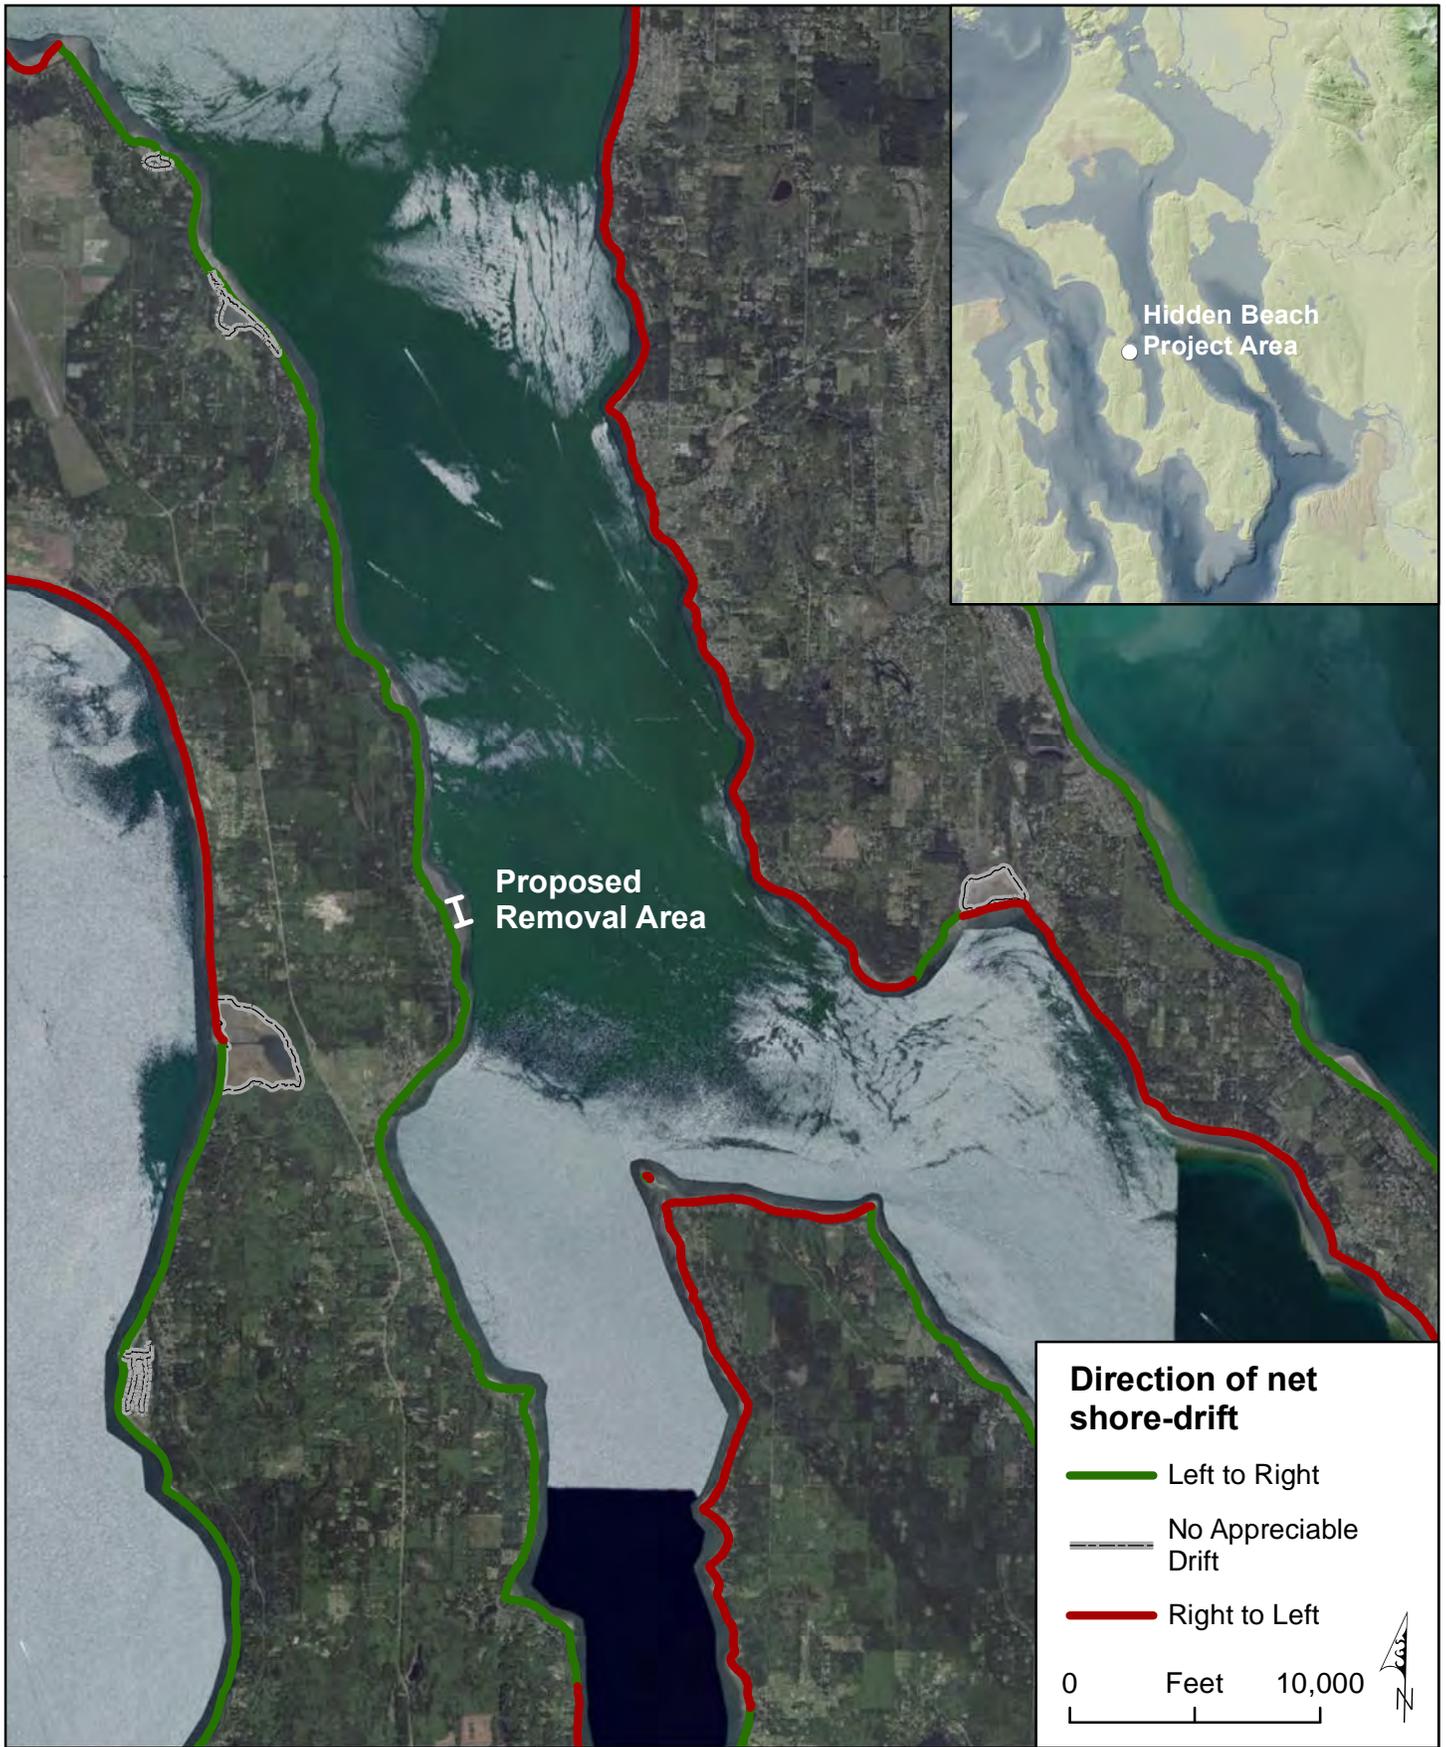
Figure 1. Proposed armor removal area at Hidden Beach, Whidbey Island, WA.

Direction of net shore-drift shown. Basemap imagery courtesy Esri.

The purpose of this preliminary design report is to outline the existing site conditions, site constraints, feasibility of armor removal, and details of the proposed armor removal and beach restoration actions specific to this coastal property. The subject of this memo is the shore along the northern extent of South Hidden Beach Drive. This site is located on the east shore of Whidbey Island in the North Bluff area just north of Greenbank (Figure 1).

divergence and extends northward until it terminates at Snakelum Point east of Penn Cove. Drift is generally northward (Figure 1). Northward net shore-drift is driven by prevailing (most common) and predominant (most frequently occurring) wind from the south and southeast. The beach has a maximum fetch (over water distance over which wind waves form) of 10.8 miles from the north, 3.15 miles from the southeast, and 9.9 miles from the east-southeast. The site is not directly exposed to waves from the south or west.

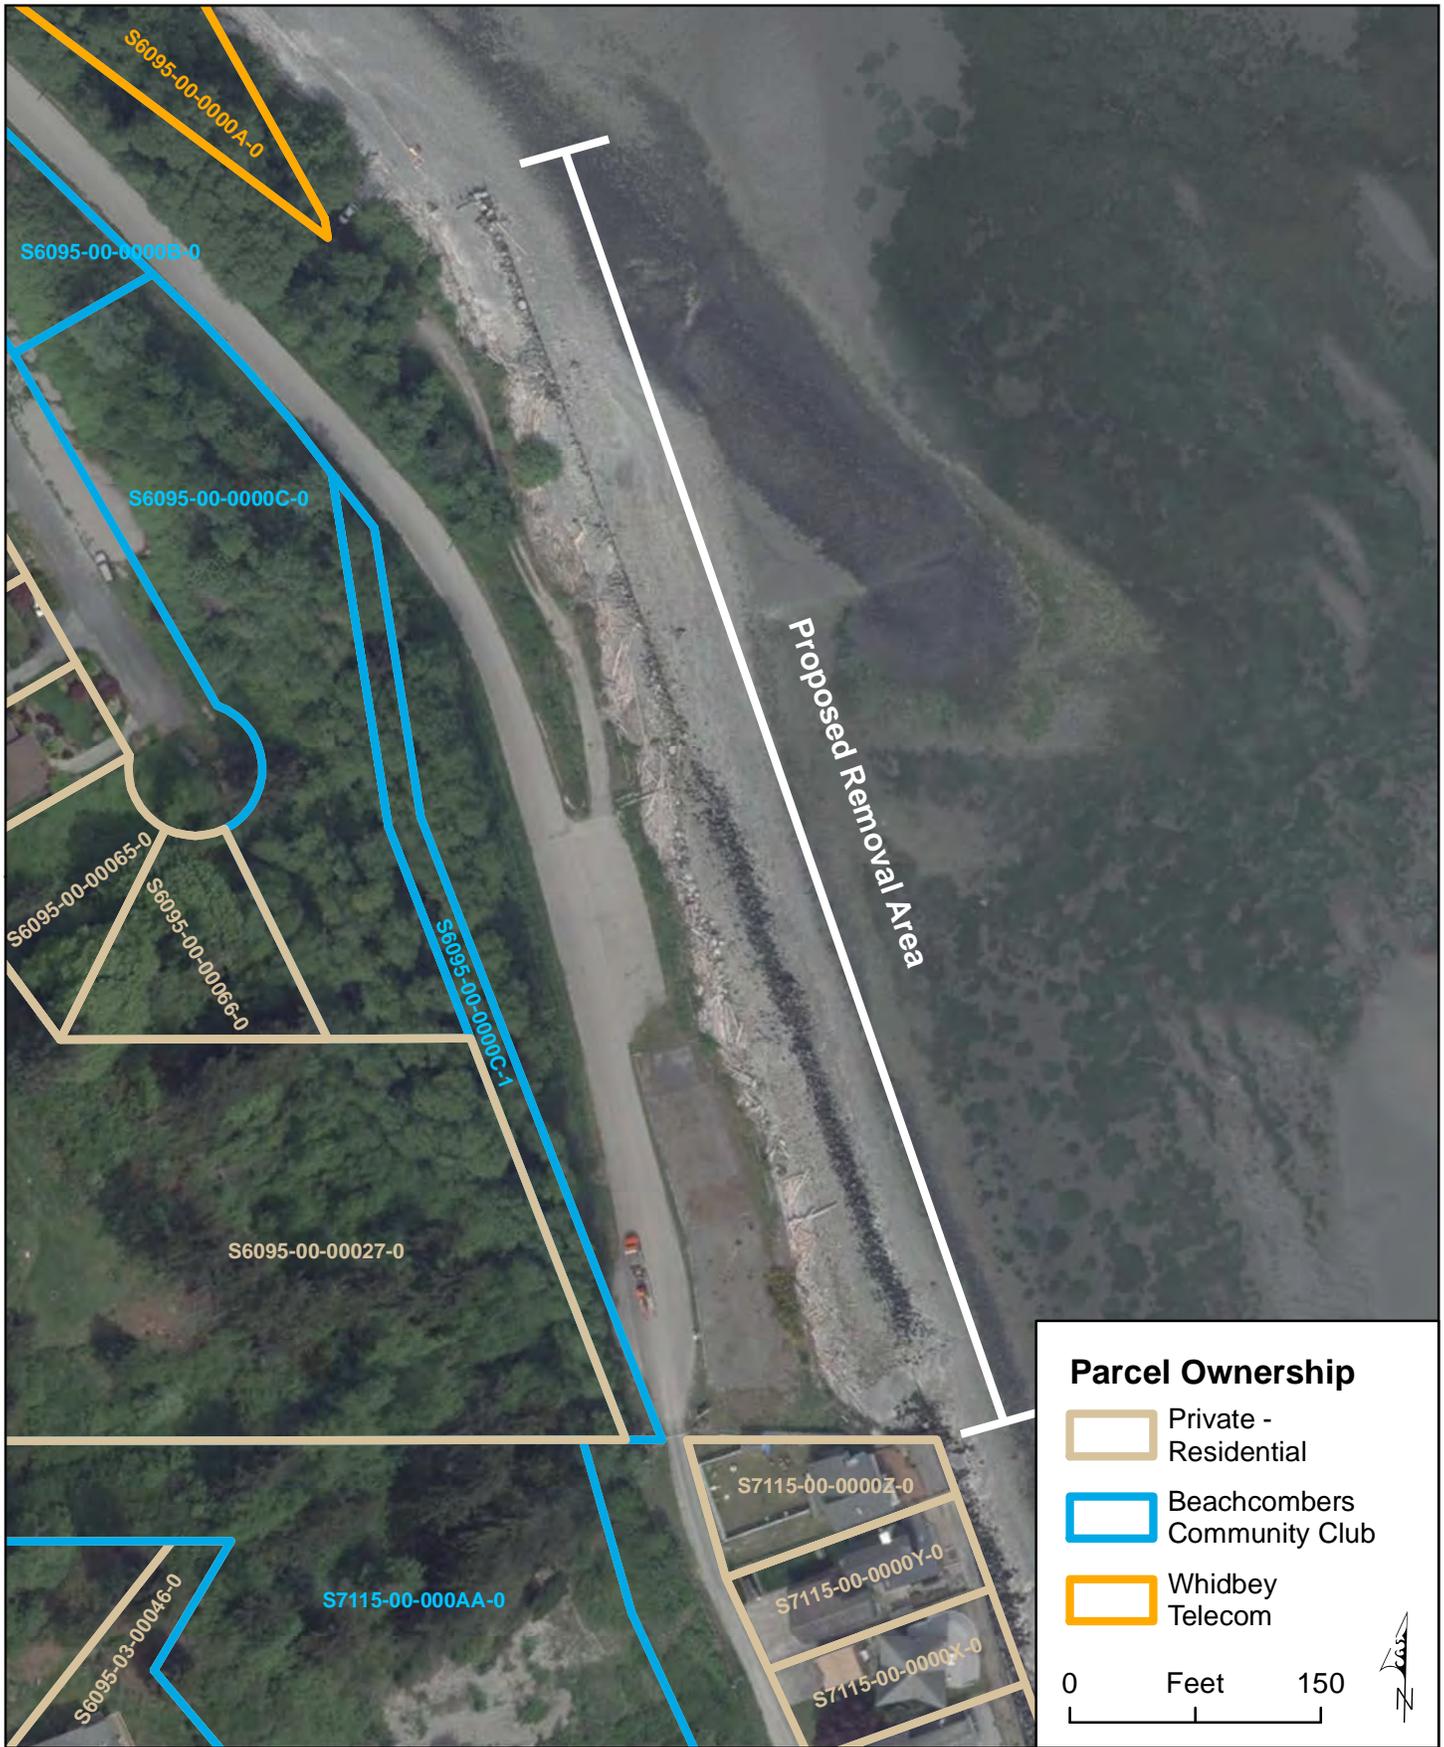
Figure 2. Parcel boundaries, ID numbers, and ownership for properties adjacent to proposed armor removal project area. Basemap imagery courtesy Esri.
 Hidden Beach Armor Removal - Northwest Straits Foundation

The parcel along the toe of the adjacent bluff located immediately adjacent to the low elevation proposed project area is owned by the Beachcombers Community Club homeowner's association (Figure 2). A narrow parcel mostly on the bluff face that is immediately north of the proposed project area is partially served by the access road parallel to the project area, and is owned by Whidbey Telecom. Parcels to the south are privately-owned (Figure 2).

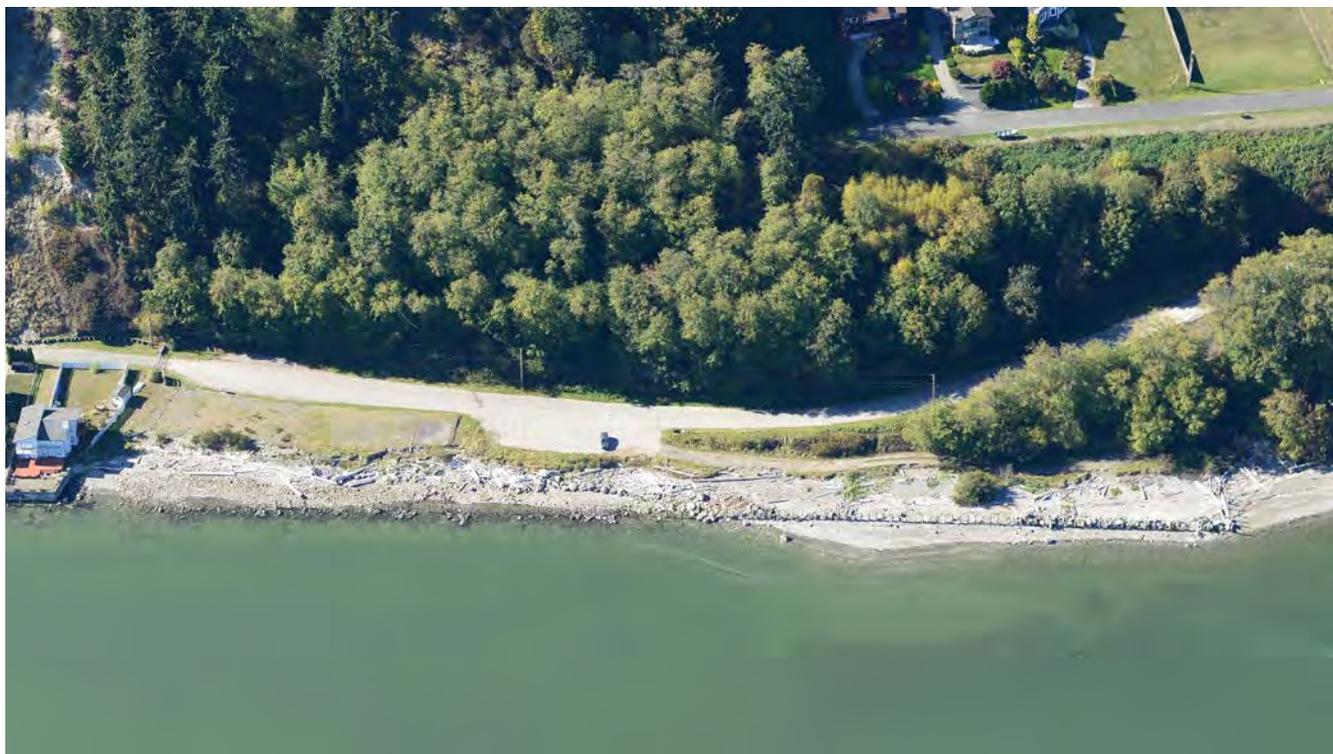
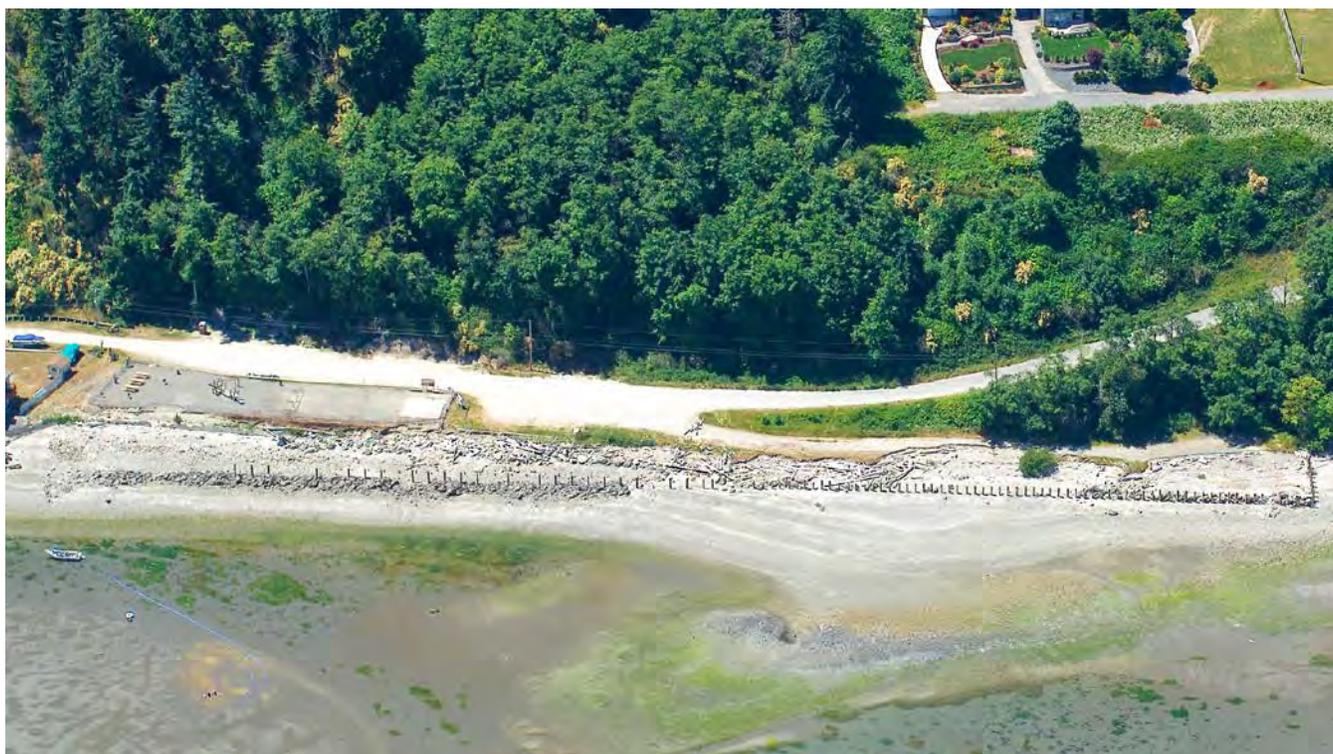
Figure 3a. Oblique aerial photographs of proposed armor removal site at Hidden Beach, 2016 (top), 2006 (bottom). Images courtesy WDOE.

The beach and shore armor is shown between 1993 and 2016 in oblique angle shoreline photos provided by WA Dept. of Ecology (Figure 3). The shore in the study area has been highly modified since 1951. A 1951 aerial photo and the 1888 T-sheet both show that the location of the old, pre-development high water line was at or very near the toe of the bluff (Figure 4). The 1888 MHW was approximately 50 – 100 FT landward of the north half of the pile wall, and approximately 100 – 140 FT landward of the south half of the pile wall.

By 2009 the full length of the shore armor had failed to the point where extensive erosion (of fill) had progressed (Figure 4). By 2006 (Figure 3a), the erosion line (OHWM) had moved to very near the

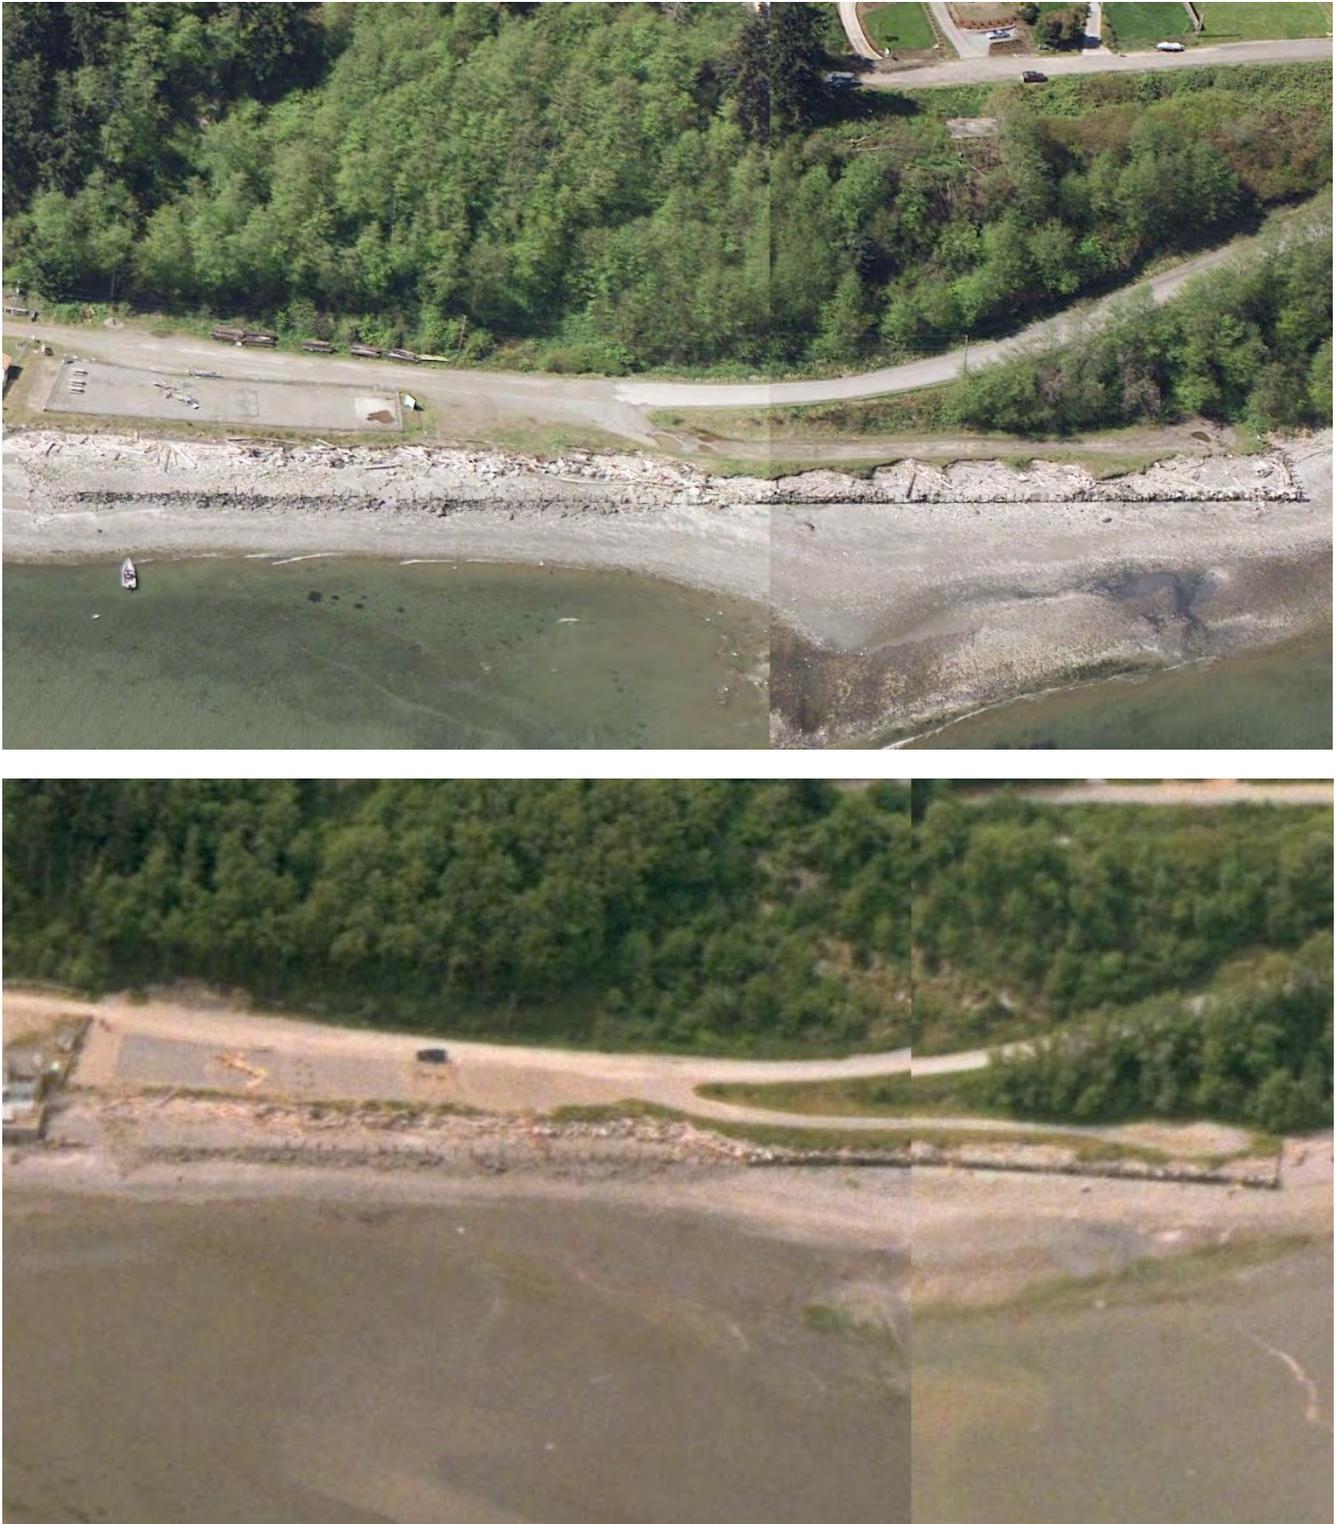
Figure 3b. Composite oblique aerial photographs of proposed armor removal site at Hidden Beach, 2001 (top), 1993 (bottom). Side-by-side images made to overlap to show entire area of interest. Images courtesy WDOE.

Houses just south of the study area were not present in either the 1968 or 1972 aerial photos (Figure 4). A loop road and some immature vegetation was present landward of the armor in 1972. The shore armor appeared to have already failed in the southern half and a little farther north by 1990 (image not included), with erosion of fill waterward of the north half of the bulkhead progressing by 1993 (Figure 3b).

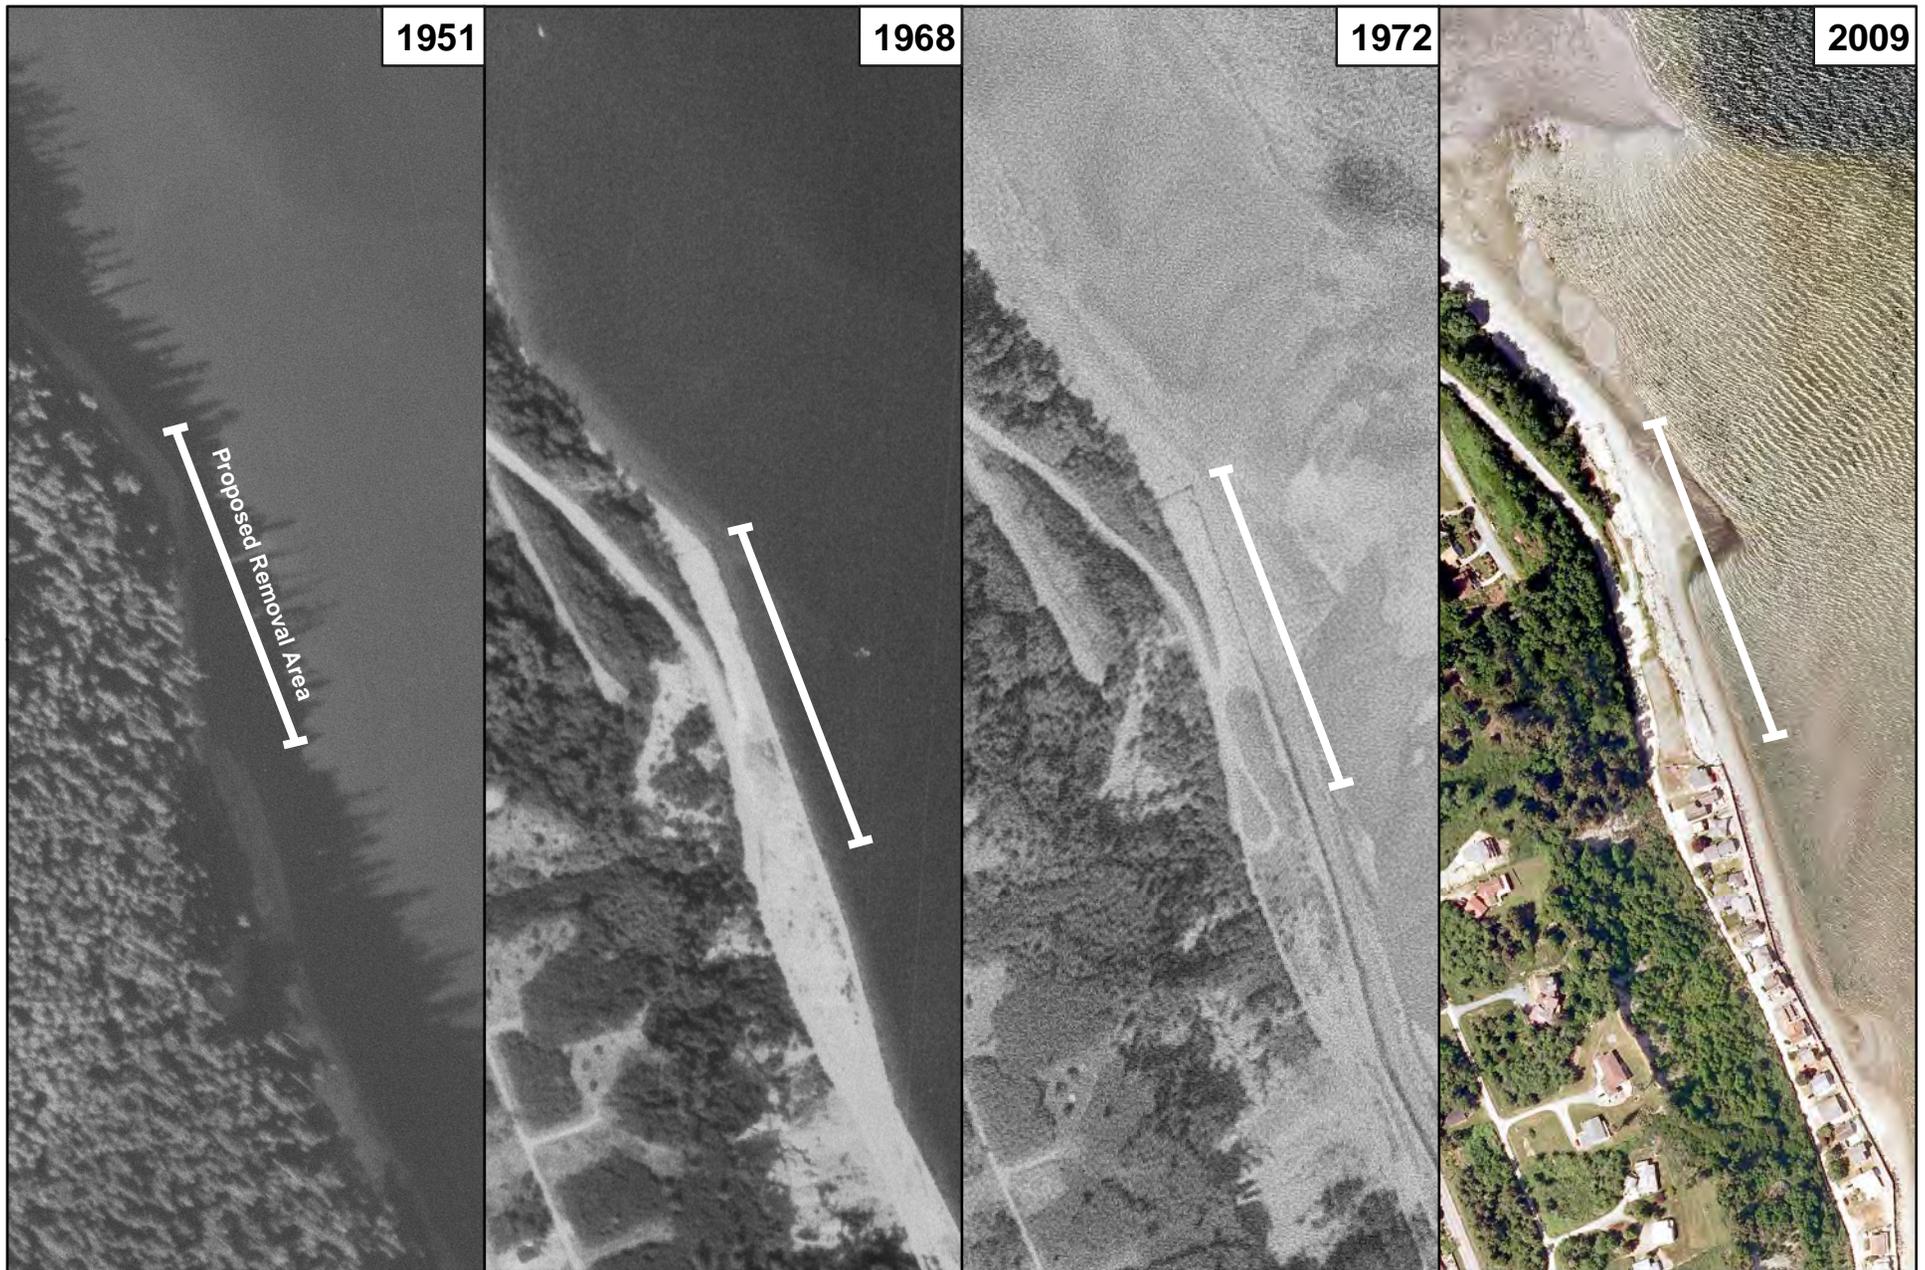
Figure 4. Historical vertical aerial photos of proposed armor removal area at Hidden Beach.

Imagery courtesy USGS 1951, 1968, 1972; Aerials Express 2009.

Comparison of the 1951 and 1968 aerial photos shows that the majority of this area appears to have been filled during this period, with mostly bare soils visible and what appears to be the linear bulkhead (800 FT long) in place by 1968 (Figure 4). South Hidden Beach Road descending the bluff was installed prior to 1968. Extensive clearcutting of the upland forest also occurred shortly before 1968. Some tree cutting may have occurred on the bluff, and several large bluff landslide areas were visible in the 1968 photo.

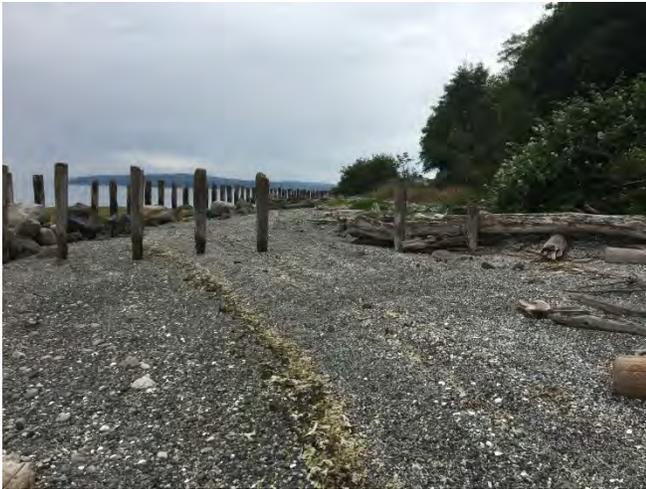
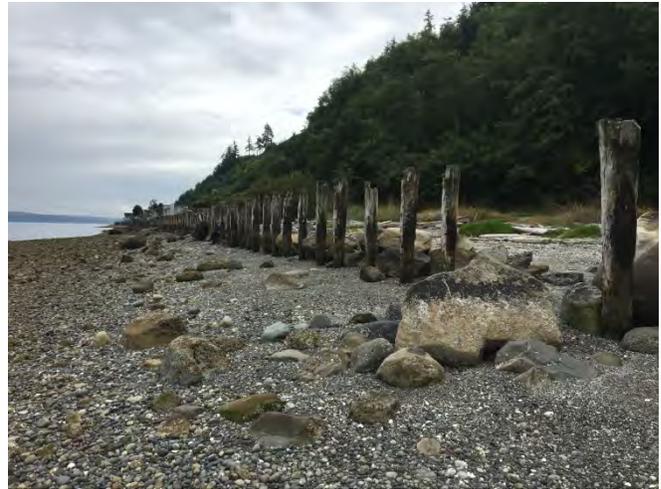
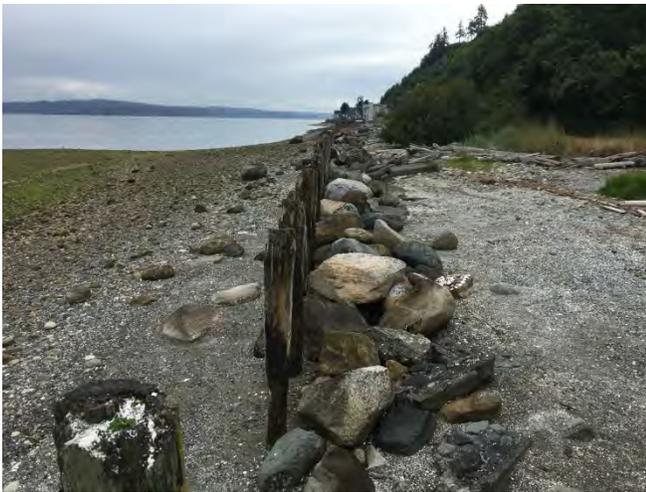
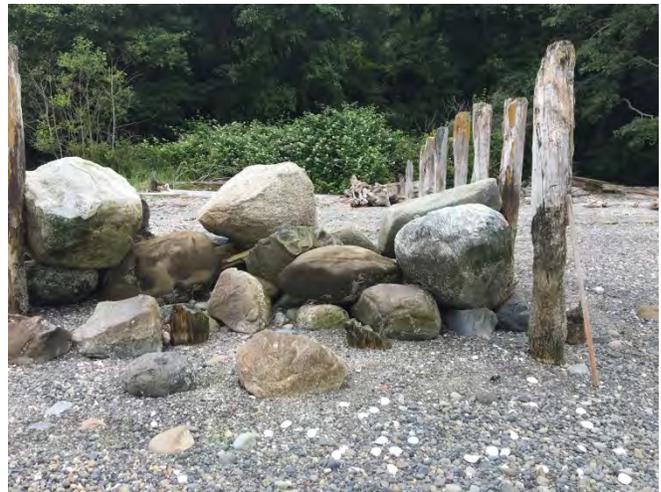
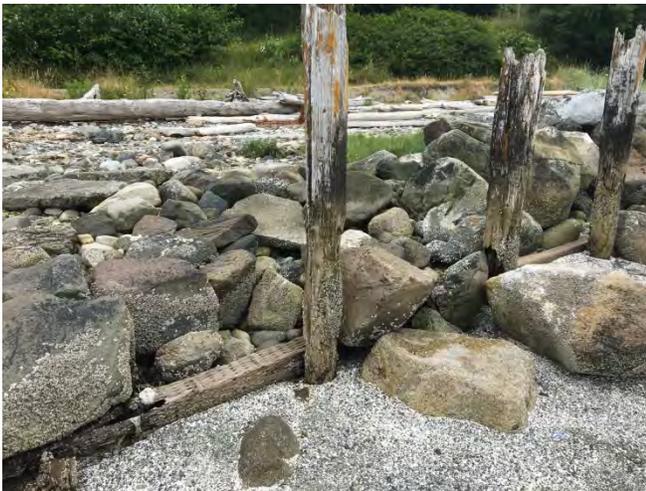
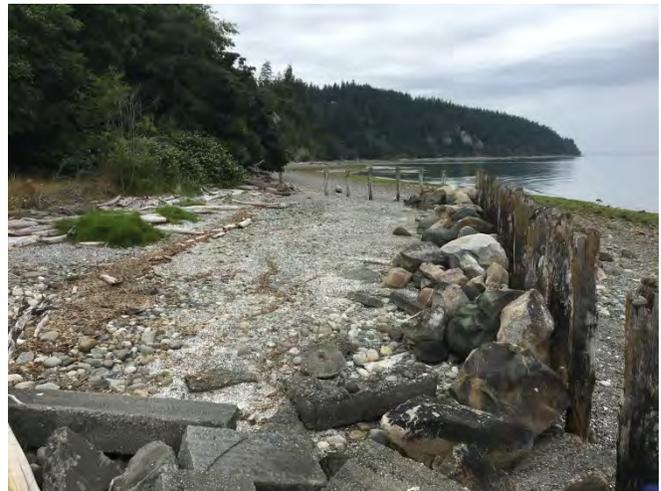
Photo Page 1. Ground photographs of the north half of shore armor at Hidden Beach, taken June 29, 2018.

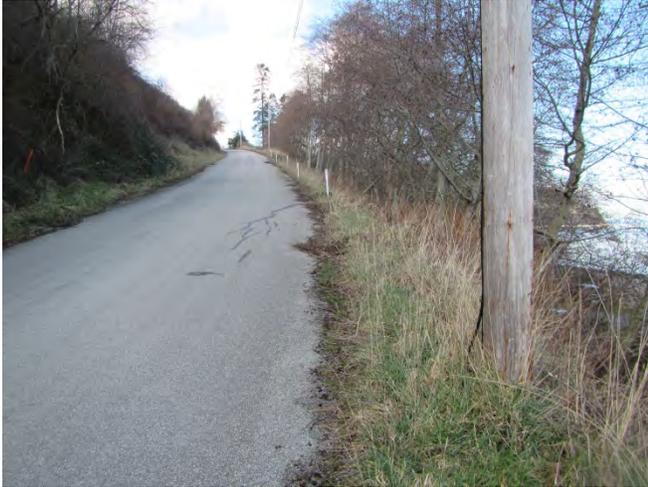
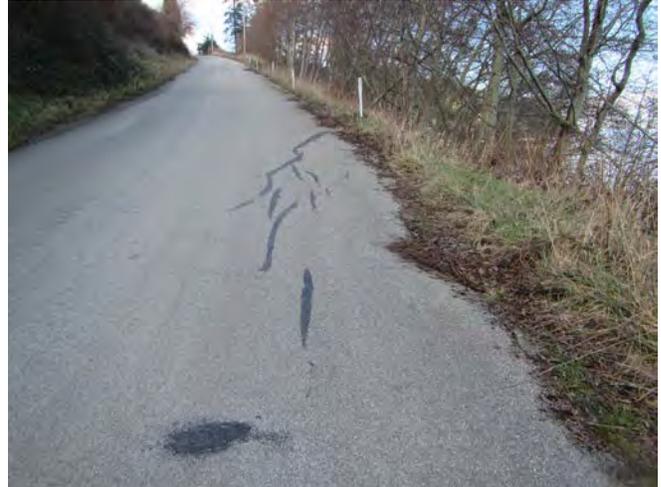
Lowest (southernmost) road crack area

Photo Page 3. Ground photographs of Hidden Beach Road showing road shoulder instability and other features, taken March 9, 2019.

Hidden Beach Road was assessed on foot along its entirety where it traverses the bluff from the north to the beach. The outboard (down slope) edge of Hidden Beach Drive has begun to show signs of slope instability, as evidenced by a set of arcuate cracks in the existing pavement section (some of which have been sealed) that encompasses an approximately 85 FT-long section of the northbound lane of the roadway (Evangelisti, 2014). This area appeared to be between elevations 45 and 85 FT (Photo Page 3).

On the waterward side of the road, four areas of pavement had cracked, and some amount of settling of the waterward portion of the outer travel lane was observed (Photo Page 3). These were noted as incipient areas of instability, likely resulting from a classic cut-and-fill road section with the outer portion of the road being comprised of fill soil. Two soil borings were completed by Landau and Associates for Island County through the existing Hidden Beach Drive where it runs down the bank towards the beach area (Evangelisti, 2014). The results of the lower elevation, deeper boring were reported as follows:

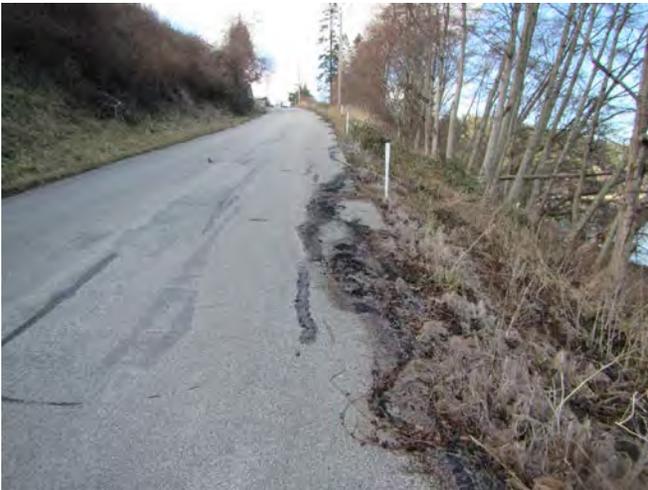
Second road crack area, north of lowest road crack area

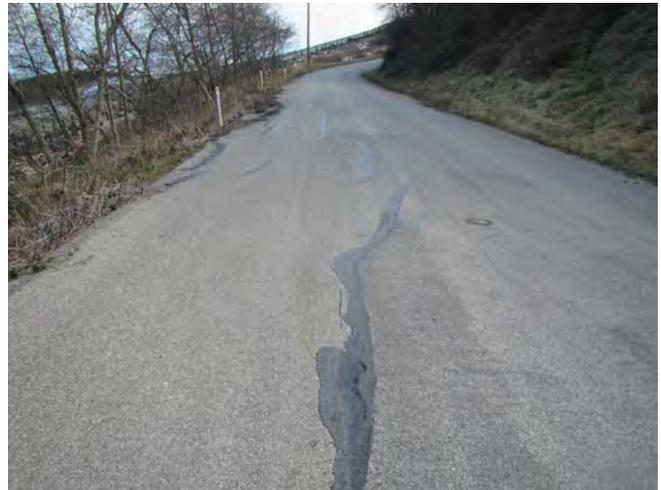
Third road crack area, facing downhill (south)

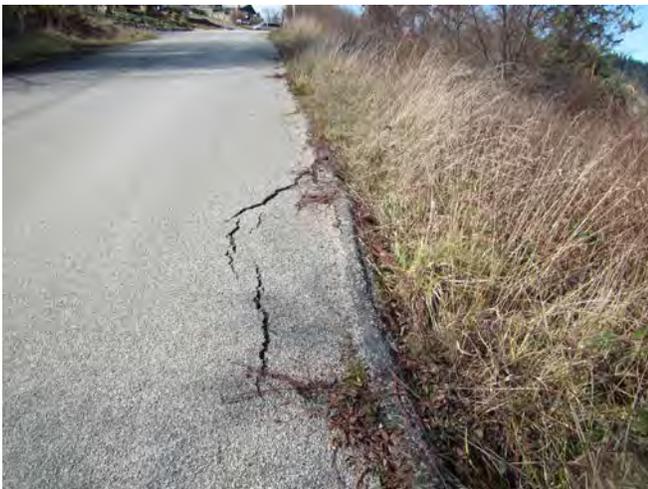
Fourth road crack area, facing uphill (north)

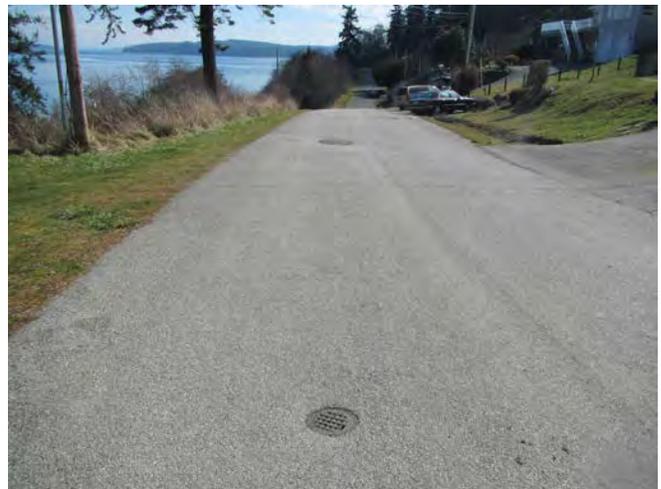
Apparent drilling and fill locations, facing downhill (south)
