## Deepwater Sidescan Sonar and Camera Surveys for Derelict Fishing Nets and Rockfish Habitat

THE NORTHWEST STRAITS FOUNDATION

NATURAL RESOURCES CONSULTANTS, INC.

January 24, 2011

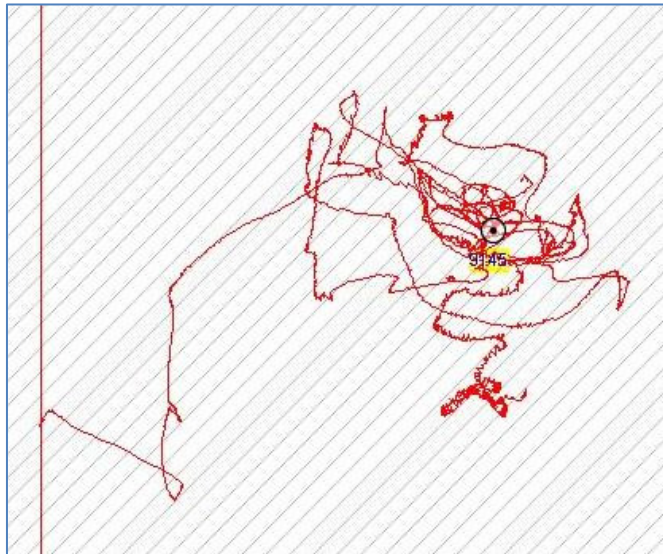
Figure 1: Date: 10/27/2010 Target: 9145

Drop camera survey efforts on October 27, 2010, focused on a net location beyond 105 feet deep, reported during previous derelict net removal operations (Gear ID: 9145 in DG database). No net or line was found at this location, however, the drop camera survey identified an extensive amount of prime rockfish habitat, such as steep rock structures with intermittent valleys and caverns. Rockfish, *Sebastes* sp. were observed at this location, as well as other fish species such as lingcod, *Ophiodon elongates*, and kelp greenling, *Hexagrammos decagrammus*. This survey covered 1.185 linear nautical miles (nm) and 0.00234 nm<sup>2</sup> (Exhibit 4, Appendix A, Figure 1).

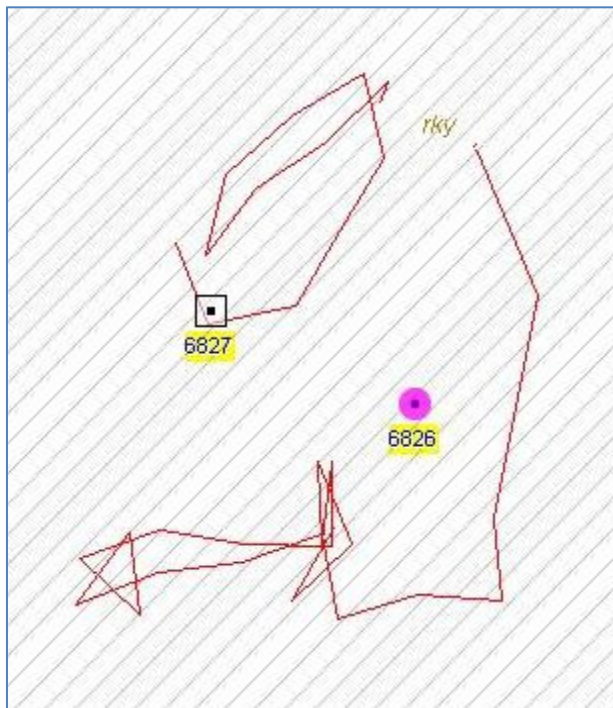
Figure 2: Date: 10/28/2010 Targets: 6826 & 6827

Drop camera survey efforts on October 28, 2010, focused on two derelict net target locations, reported during previous derelict net removal operations (Gear ID: 6826 and 6827 in DG database). Both net and lead line were found at these locations. The net was tubed up and wrapped around the face of a rock pinnacle and stretched across a flat area at the base of the structure. The camera survey also identified an extensive amount of prime rockfish habitat, such as steep rock structures with intermittent valleys and caverns. This survey covered 0.193 linear nm and 0.000381 nm<sup>2</sup> (Exhibit 4, Appendix A, Figure 2).

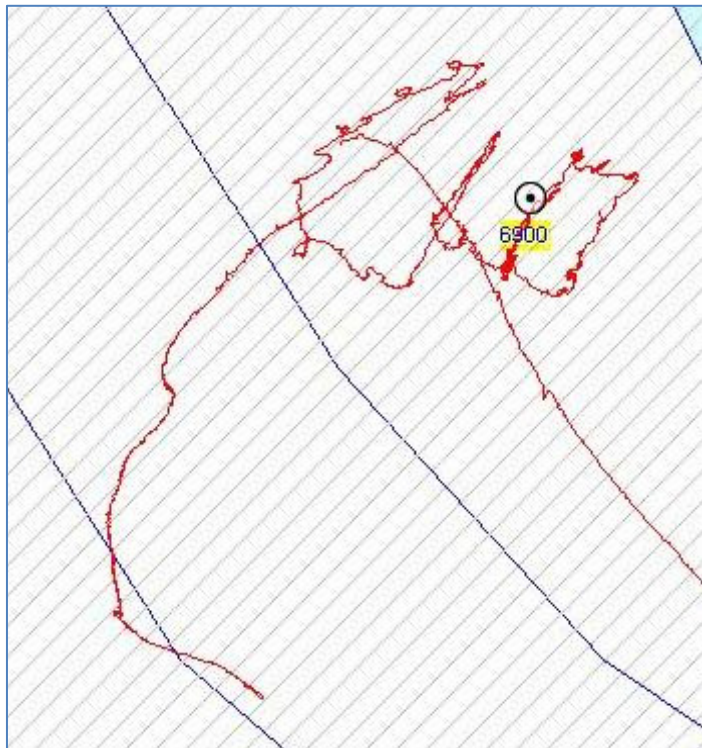
Figure 3: Date: 10/29/10 Target: 6900

Drop camera survey efforts on October 29, 2010, focused on a net target location reported during previous derelict net removal operations (Gear ID: 6900 in DG database). No net or line was found at this location, however, the camera survey identified an extensive amount of prime rockfish habitat such as steep rock structures with intermittent valleys and caverns. Rockfish were observed at this location, as well as other species such as lingcod and kelp greenling. The survey covered 0.351 linear nm and 0.000462 nm<sup>2</sup> (Exhibit 4, Appendix A, Figure 3).

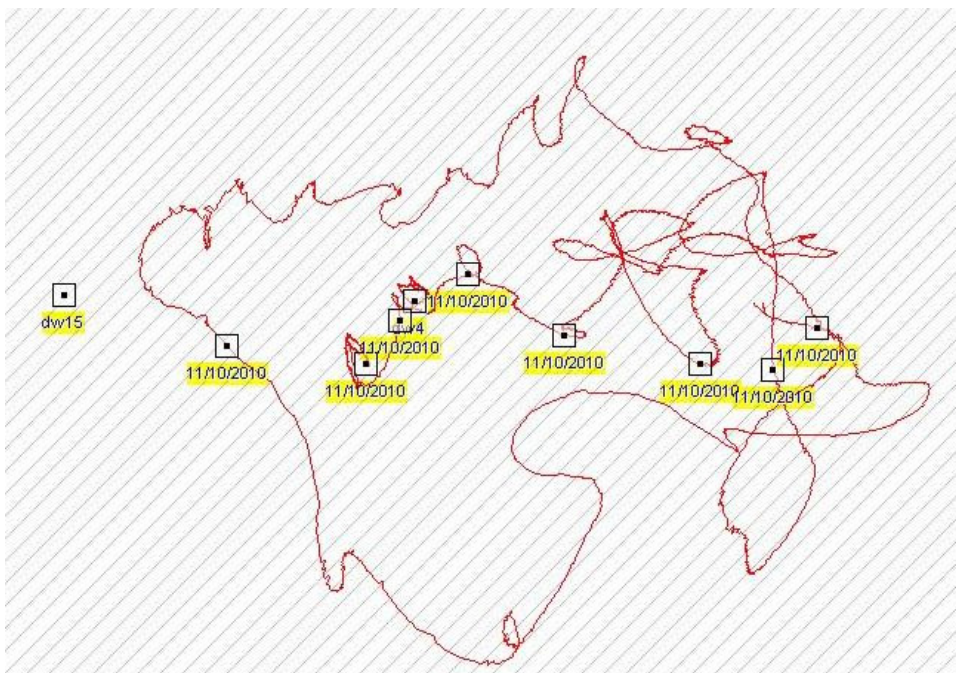
Figure 5: Date: 11/10/10 Target: DW9.

it is very likely that the web is buried under the sand. Depending on sea state conditions and the season, this web may be exposed during part of the year, similar to observations of other derelict nets during dive removals on nearby Salmon Bank. This area had a sandy bottom with boulders ranging in size from 1.5 to 6.5 feet (0.5 to 2 meters) and ranging in height to 3 feet (1 meter). The total drop camera survey coverage was 0.860 linear nm and 0.001698 nm<sup>2</sup> (Exhibit 4, Appendix A, Figures 4, 5 and 6).

| Target ID | Gear Type | Min Depth (ft) | Max Depth (ft) | Investigation Status | Location | Latitude | Longitude | Date of Drop Camera Investigation | Additional Targets Found | Habitat type | Rockfish Habitat | Rockfish Present | Rockfish Risk | Comments |
|---|---|---|---|---|---|---|---|---|---|---|---|---|---|--|
| dw9 | Gillnet | 118 | 128 | Net Found | Eagle Point | 48 27.242 | 123 01.301 | 11/10/10 | 9 | Sand Bottom with boulders | Nearby | No | Low/Mod | Only lead lines observed by net may be buried in sand |

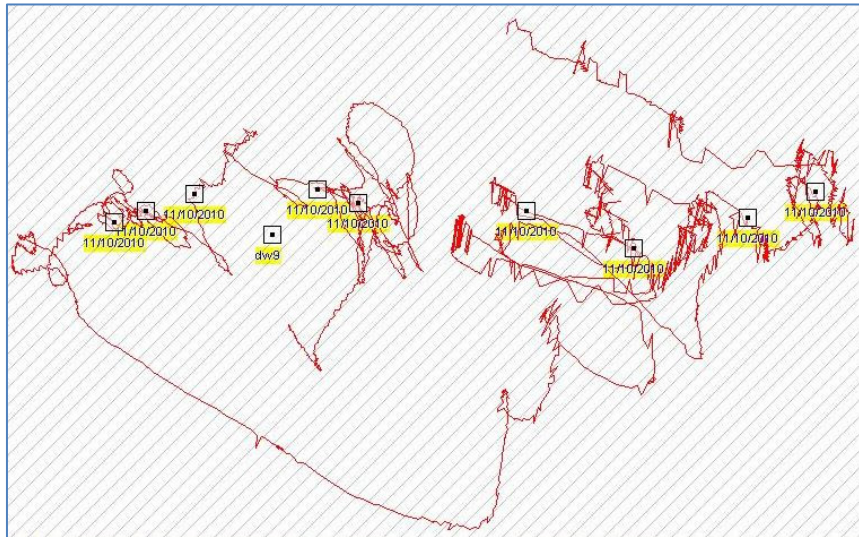
Figure 6: Date: 11/10/10 Targets: DW2 and DW14.

| Target ID | Gear Type | Min Depth (ft) | Max Depth (ft) | Investigation Status | Location | Latitude | Longitude | Date of Drop Camera Investigation | Additional Targets Found | Habitat type | Rockfish Habitat | Rockfish Present | Rockfish Risk | Comments |
|---|---|---|---|---|---|---|---|---|---|---|---|---|---|--|
| dw2 | Gillnet | 112 | 130 | Net Found | Eagle Point | 48 27.250 | 123 01.189 | 11/10/10 | 6 | Sand Bottom with boulders | Nearby | No | Low/Mod | Only lead lines observed by net may be buried in sand |
| dw14 | Gillnet | 114 | 127 | Net Found | Eagle Point | 48 27.241 | 123 01.227 | 11/10/10 | | Sand Bottom with boulders | Nearby | No | Low/Mod | Only lead lines observed by net may be buried in sand |

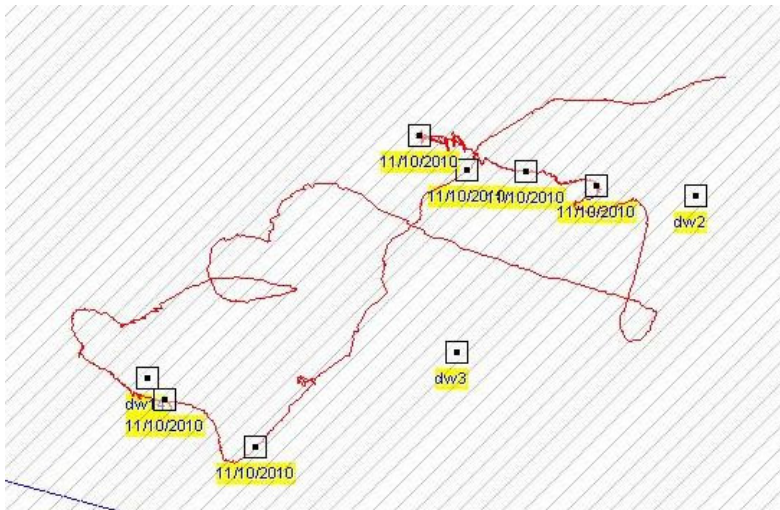
Figure 7: Date: 11/12/10 Target: DW16.

Drop camera survey efforts on November 10, 2010, focused on four derelict net target locations, located during sidescan survey (Gear ID: DW16, DW18, DW31 and DW 30 in DG database). Lead line was found at the first three of these areas. These areas had a sandy bottom with boulders ranging in size from 1.5 to 6.5 feet (0.5 to 2 meters) and ranging in height to 3 feet (1 meter). While only lead line was captured on video, it is very likely that the web is buried under the sand. Depending on sea state conditions and the season, this web may be exposed during part of the year. While surveying for DW30 an increase in current made it impossible to effectively cover the area. The total coverage was 0.699 nm and 0.001381 nm<sup>2</sup> (Exhibit 4, Appendix A, Figures 7, 8 and 9).

| Target ID | Gear Type | Min Depth (ft) | Max Depth (ft) | Investigation Status | Location | Latitude | Longitude | Date of Drop Camera Investigation | Additional Targets Found | Habitat type | Rockfish Habitat | Rockfish Present | Rockfish Risk | Comments |
|---|---|---|---|---|---|---|---|---|---|---|---|---|---|--|
| dw16 | Gillnet | 111 | 127 | Net Found | Eagle Point | 48 27.284 | 123 01.432 | 11/12/10 | 5 | Sand Bottom with boulders | Nearby | No | Low/Mod | Only lead lines observed by net may be buried in sand |

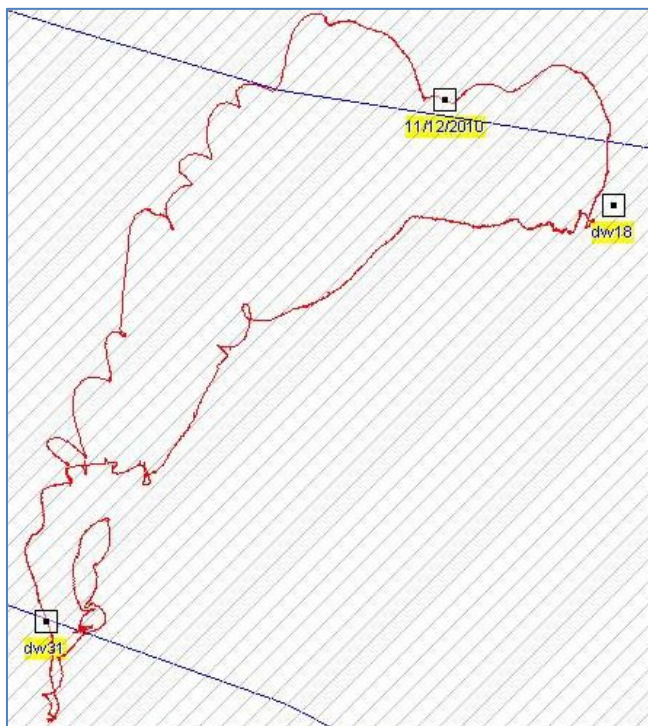
Figure 8: Date: 11/12/10 Targets: DW18 & DW31

| Target ID | Gear Type | Min Depth (ft) | Max Depth (ft) | Investigation Status | Location | Latitude | Longitude | Date of Drop Camera Investigation | Additional Targets Found | Habitat type | Rockfish Habitat | Rockfish Present | Rockfish Risk | Comments |
|---|---|---|---|---|---|---|---|---|---|---|---|---|---|--|
| dw18 | Gillnet | 113 | 124 | Net Found | Eagle Point | 48 27.419 | 123 01.886 | 11/12/10 | 1 | Sand Bottom with boulders | Nearby | No | Low/Mod | Only lead lines observed by net may be buried in sand |
| dw31 | Gillnet | 118 | 128 | Net Found | Eagle Point | 48 27.382 | 123 01.962 | 11/12/10 | | Sand Bottom with boulders | Nearby | No | Low/Mod | Only lead lines observed by net may be buried in sand |

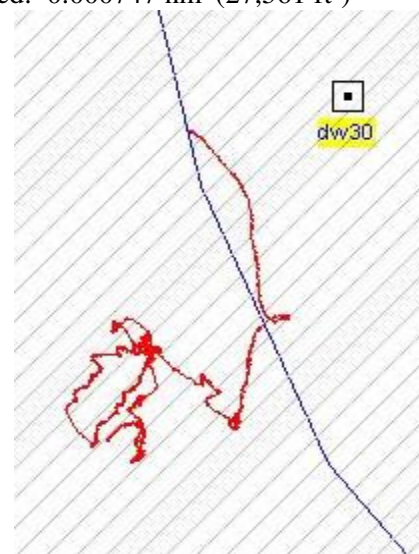
Figure 9: Date: 11/12/10 Target: DW30

| Target ID | Gear Type | Min Depth (ft) | Max Depth (ft) | Investigation Status | Location | Latitude | Longitude | Date of Drop Camera Investigation | Additional Targets Found | Habitat type | Rockfish Habitat | Rockfish Present | Rockfish Risk | Comments |
|---|---|---|---|---|---|---|---|---|---|---|---|---|---|--|
| dw30 | Gillnet | 115 | 220 | Net Found | Eagle Point | 48 27.550 | 123 02.500 | 11/28/10 | 26 | Large Rock Structure with sand/shell base | Yes | Yes | High | Rockfish, lingcod, kelp greenling, Puget Sound king crab, red sea urchins, sea cucumbers |
